SIM 61 07 20

RECALL 20V-601: HIGH-VOLTAGE BATTERY

E-Series	Model Description	Production Date
F60	MINI Cooper SE Countryman ALL4–PHEV Only	March 12, 2020 – September 15, 2020

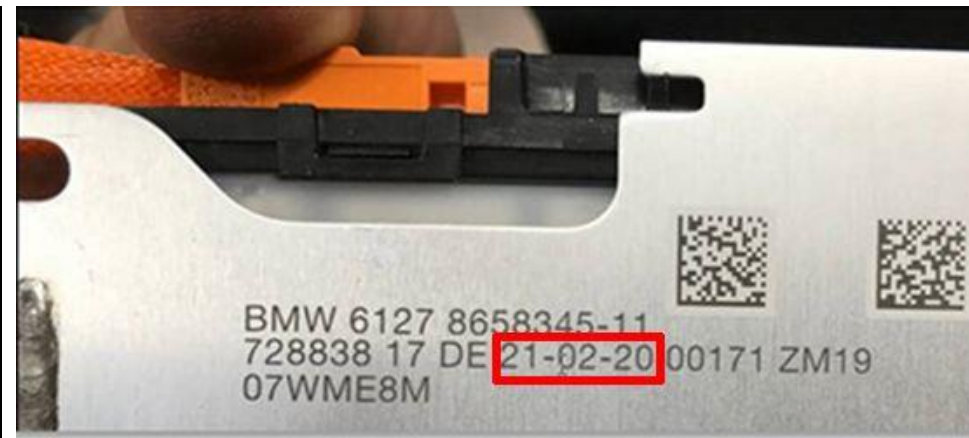
The date in the serial number of the high-voltage module can be displayed in two different formats.

Variant A : YY-MM-DD

**Variant B (shown):
DD-MM-YY**
