SIB 61 23 20

RECALL 20V-601: HIGH-VOLTAGE BATTERY

This Service Information Bulletin (Revision 3) replaces SI B61 23 20 **dated December 2020**.

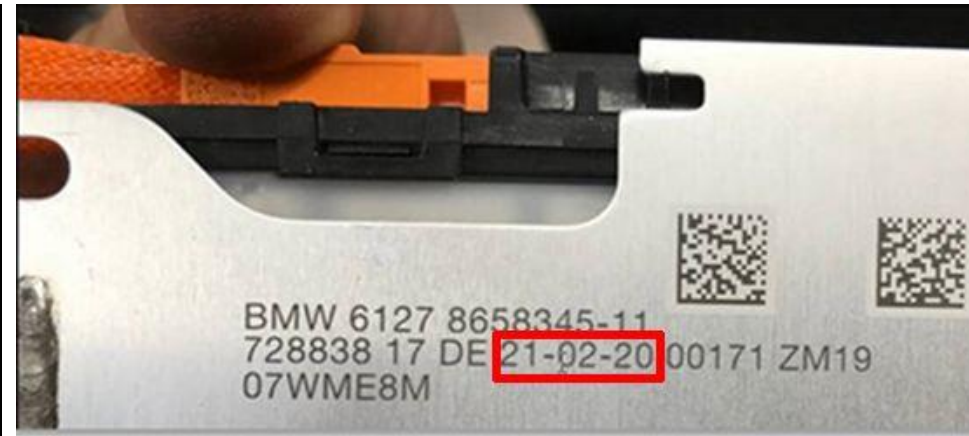
The date in the serial number of the High-voltage module can be displayed in two different formats:

Variant A: YYMMDD
--	--------------------------

Variant B (shown here): DDMMYY

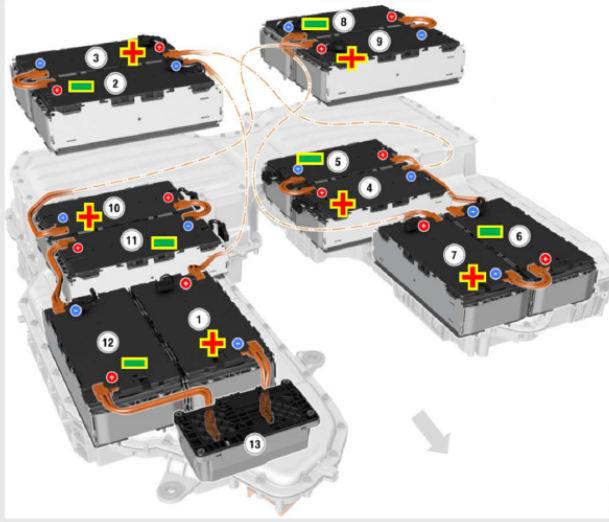
G05 modules are POS or NEG

Use EPC diagram to order the correct module polarity. The correct locations of the modules are displayed in illustration.

- Module 12 is **NEG**
- Module 1 is **POS**
- Module 11 is **NEG**
- Module 10 is **POS**
- Module 2 is **NEG**
- Module 3 is **POS**
- Module 8 is **NEG**
- Module 9 in **POS**
- Module 5 is **NEG**
- Module 4 is **POS**
- Module 6 is **NEG**
- Module 7 in **POS**
