SIB 61 23 20

2022-04-28

RECALL 20V-601: HIGH-VOLTAGE BATTERY RECALL

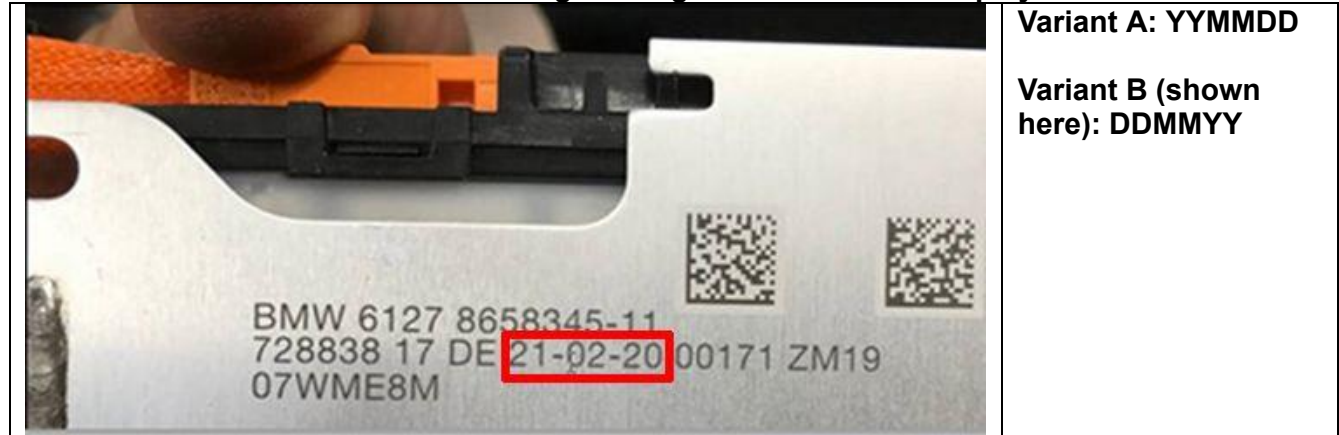
The date in the serial number of the High-voltage module can be displayed in two different formats:

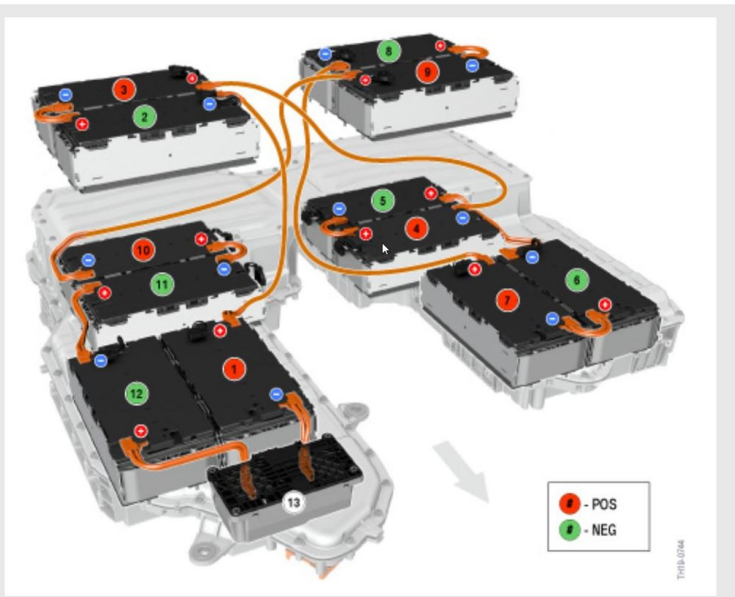
SP44 HV Battery (G05) modules-

G05 modules (SP44 HV battery) are:

- Module 12 is **NEG (01)**
- Module 1 is **POS (02)**
- Module 11 is **NEG (01)**
- Module 10 is **POS (02)**
- Module 2 is **NEG (01)**
- Module 3 is **POS (02)**
- Module 8 is **NEG (01)**
- Module 9 is **POS (02)**
- Module 5 is **NEG (01)**
- Module 4 is **POS (02)**
- Module 6 is **NEG (01)**
- Module 7 in **POS (02)**

Modules are designed as Positive and Negative modules (with different orientation and part numbers). When replacing modules, verify in EPC the correct part (POS/NEG) and reinstall according to their original position. See below.

Use EPC diagram to verify the correct module part number (01/02) for NEG or POS modules.

Use the illustration on the right to match the part# with the correct module installation location.

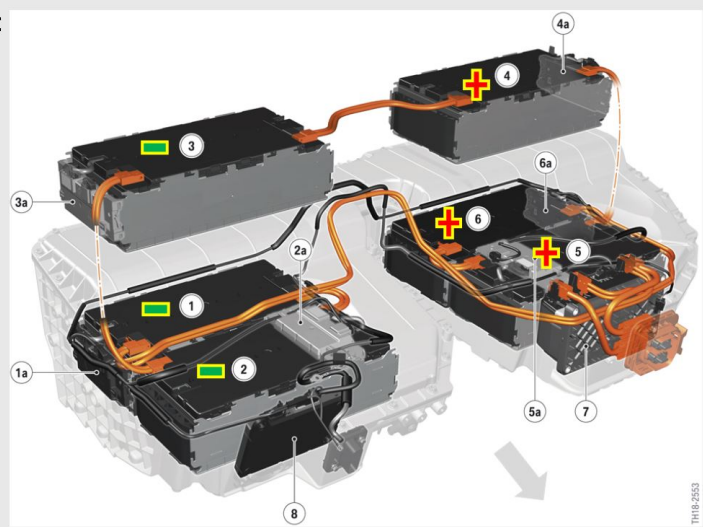
SP41 HV Battery (G01/G20/G20/G12) modules-

G01/G20/G30/G12 LCI modules (SP41 battery) are:**NEG (01) or POS (02)**

- Module 1 is **NEG (01)**
- Module 2 is **NEG (01)**
- Module 3 is **NEG (01)**
- Module 4 is **POS (02)**
- Module 5 is **POS (02)**
- Module 6 is **POS (02)**

Use EPC diagram to verify the correct module part number (01/02) for NEG or POS modules.

Use the illustration on the right to match the part# with the correct module installation location.
