SIB 61 23 20

2021-01-21

## RECALL 20V-601: HIGH-VOLTAGE BATTERY RECALL

This Service Information Bulletin (Revision 5) replaces SI B61 23 20 **dated December 2020**.

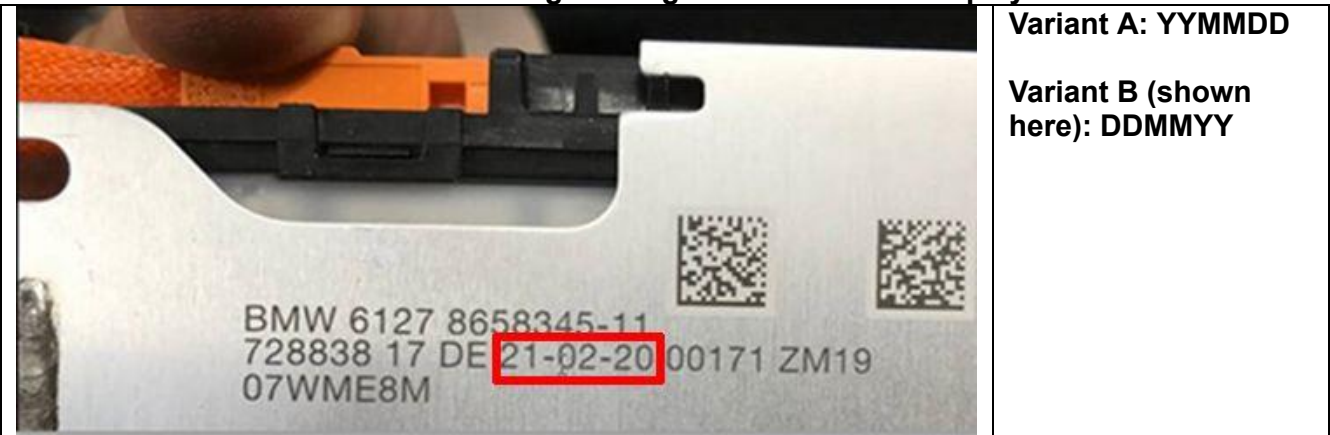
**Note:**

The date in the serial number of the High-voltage module can be displayed in two different formats:

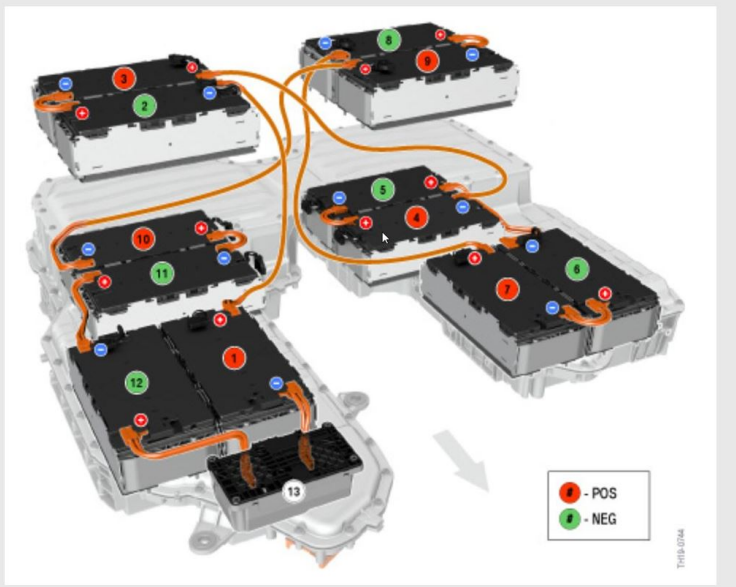
**SP44 HV Battery (G05) modules-**

**G05 modules (SP44 HV battery) are:**

**NEG (01) or POS (02)**

- Module 12 is **NEG (01)**
- Module 1 is **POS (02)**
- Module 11 is **NEG (01)**
- Module 10 is **POS (02)**
- Module 2 is **NEG (01)**
- Module 3 is **POS (02)**
- Module 8 is **NEG (01)**
- Module 9 in **POS (02)**
- Module 5 is **NEG (01)**
- Module 4 is **POS (02)**
- Module 6 is **NEG (01)**
- Module 7 in **POS (02)**

**Modules are designed as Positive and Negative modules (with different orientation and part numbers). When replacing modules, verify in EPC the correct part (POS/NEG) and reinstall according to their original position. See below.**

Use EPC diagram to verify the correct module part number (01/02) for NEG or POS modules.

Use the illustration on the right to match the part# with the correct module installation location.

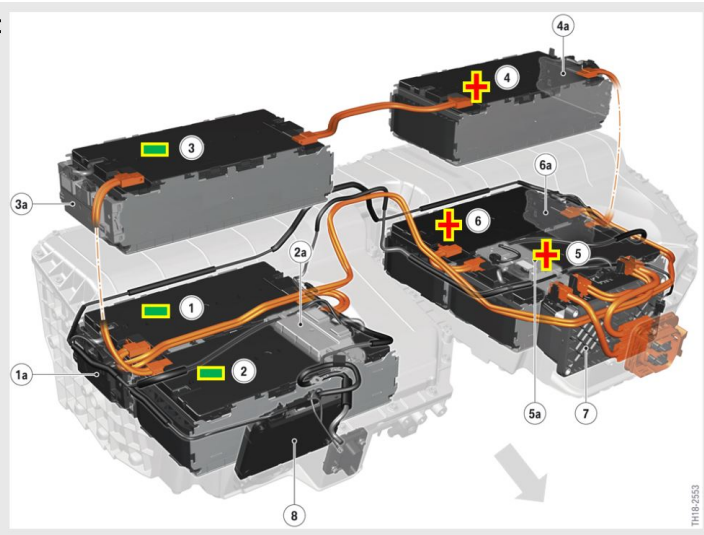
**SP41 HV Battery (G01/G20/G20/G12) modules-**

**G01/G20/G30/G12 LCI modules (SP41 battery) are:**

**NEG (01) or POS (02)**

- Module 1 is **NEG (01)**
- Module 2 is **NEG (01)**
- Module 3 is **NEG (01)**
- Module 4 is **POS (02)**
- Module 5 is **POS (02)**
- Module 6 is **POS (02)**

Use EPC diagram to verify the correct module part number (01/02) for NEG or POS modules.

Use the illustration on the right to match the part# with the correct module installation location.
