SIB 61 23 20

2021-02-19

RECALL 20V-601: HIGH-VOLTAGE BATTERY RECALL

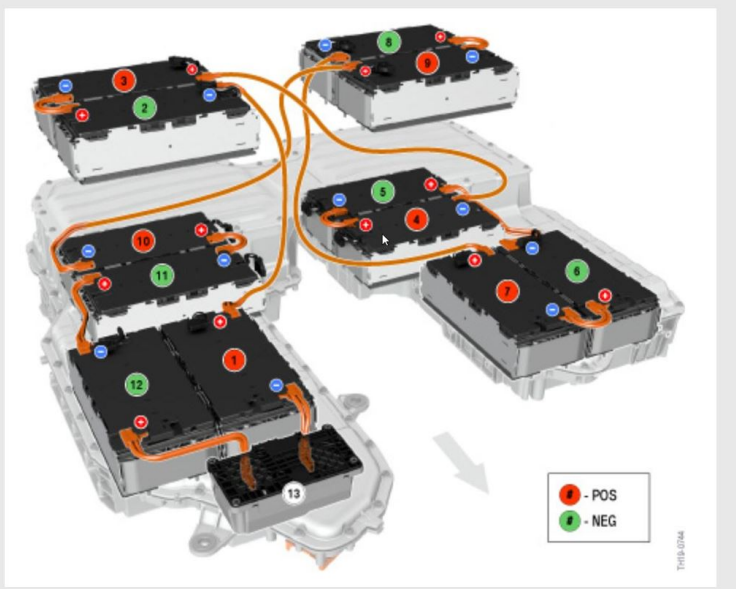
SP44 HV Battery (G05) modules-

G05 modules (SP44 HV battery) are:

NEG (01) or POS (02)

- Module 12 is **NEG (01)**
- Module 1 is **POS (02)**
- Module 11 is **NEG (01)**
- Module 10 is **POS (02)**
- Module 2 is **NEG (01)**
- Module 3 is **POS (02)**
- Module 8 is **NEG (01)**
- Module 9 in **POS (02)**
- Module 5 is **NEG (01)**
- Module 4 is **POS (02)**
- Module 6 is **NEG (01)**
- Module 7 in **POS (02)**

Use EPC diagram to verify the correct module part number (01/02) for NEG or POS modules.

Use the illustration on the right to match the part# with the correct module installation location.
