SIB 61 23 20

RECALL 20V-601: HIGH-VOLTAGE BATTERY

This Service Information Bulletin (Revision 4) replaces SI B61 23 20 **dated December 2020**.

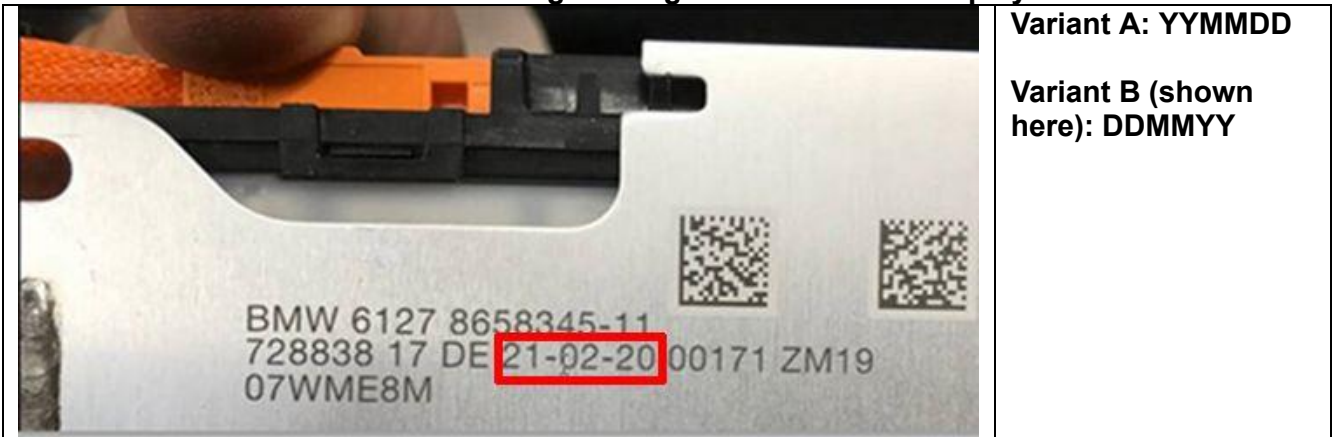
Note:

The date in the serial number of the High-voltage module can be displayed in two different formats:

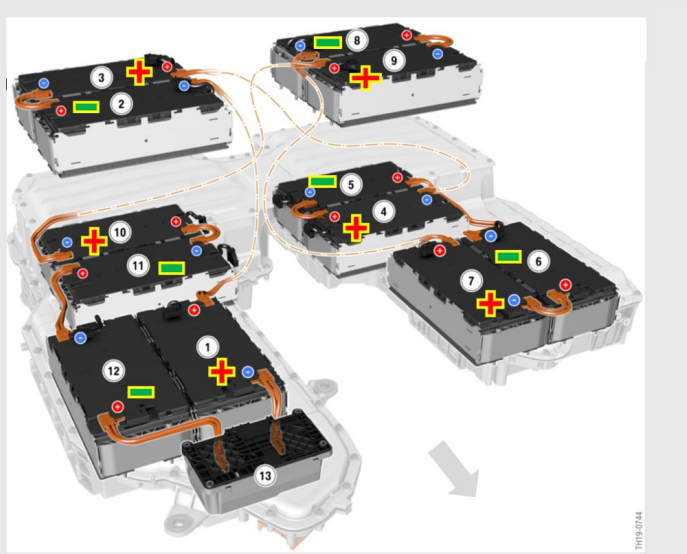
SP44 HV Battery (G05) modules

G05 modules (SP44 HV battery) are:

NEG (01) or POS (02)

- Module 12 is **NEG (01)**
- Module 1 is **POS (02)**
- Module 11 is **NEG (01)**
- Module 10 is **POS (02)**
- Module 2 is **NEG (01)**
- Module 3 is **POS (02)**
- Module 8 is **NEG (01)**
- Module 9 is **POS (02)**
- Module 5 is **NEG (01)**
- Module 4 is **POS (02)**
- Module 6 is **NEG (01)**
- Module 7 is **POS (02)**

Use EPC diagram to verify the correct module part number (01/02) for NEG or POS modules.

Use the illustration on the right to match the part# with the correct module installation location.

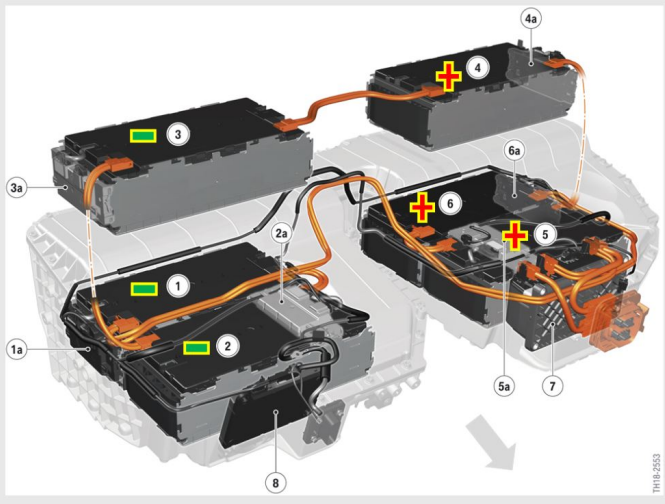
SP41 HV Battery (G01/G20/G20/G12) modules

G01/G20/G30/G12 LCI modules (SP41 battery) are:**NEG (01) or POS (02)**

- Module 1 is **NEG (01)**
- Module 2 is **NEG (01)**
- Module 3 is **NEG (01)**
- Module 4 is **POS (02)**
- Module 5 is **POS (02)**
- Module 6 is **POS (02)**

Use EPC diagram to verify the correct module part number (01/02) for NEG or POS modules.

Use the illustration on the right to match the part# with the correct module installation location.
