N499NAS2

TECHNICAL BULLETIN

08 JUL 2021

SAFETY RECALL: Rear Spoiler Outer Surface Retention

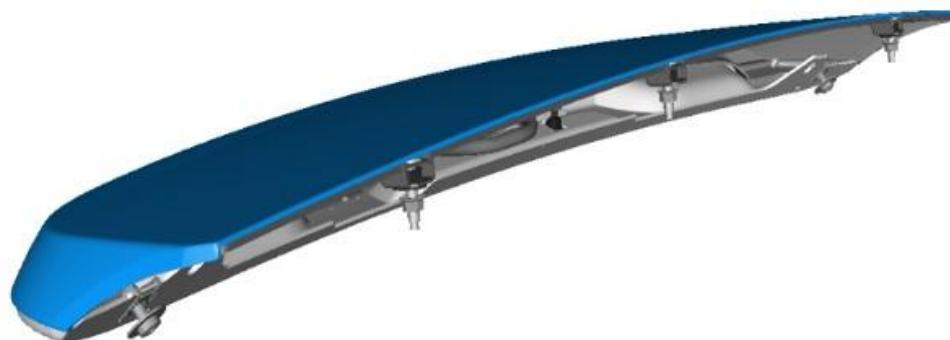
E260468

Inspect the rear spoiler to see if the outer surface of the rear spoiler is fully secured to the inner carrier molding.

- If the outer surface of the rear spoiler **is not** fully secured, **apply adhesive tape to secure the outer surface of the rear spoiler to the inner carrier molding and then continue to step 3.**
 - If the outer surface of the rear spoiler **is** fully secured, **continue to step 3.**
-
