Campaign No. 2020100015, November 2020  
Revision A

SUBJECT: **Model GLE-Class and GLS-Class vehicles (167 platform)**  
**Model Year 2020**  
**Installation of the Illuminate Star**

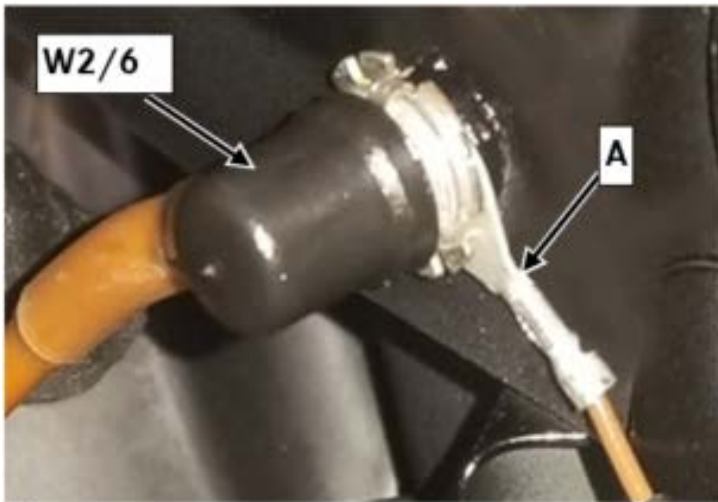
Figure 1

- Check ground line clearance.
- Ground line may be zip tied to shorten original length.
- Check behind the illuminated star for any possible zip ties around the ground wire.
- Zip ties may be removed for extra length if needed.

1. Open hood.
2. Switch off ignition and store transmitter key outside the transmitter range (at least 2 meters).
3. Unscrew ground **point W2/6**.  
i For basic data, see **GF00.19-P-2001-17NCA**.
4. Remove illuminated star ground line (**A, figure 1**).

6. Route illuminated star ground line (**A, figure 1**) to jump-start connection point and attach to threaded pin of jump-start connection point.
7. Screw on brass sleeve (**B, figure 2**).  
**Hm** Brass sleeve 16 Nm.
8. Secure illuminated star ground line (**A, figure 1**) up to jump-start connection point.  
**i** Ensure a chafe-free routing and attachment of the illuminated star ground line See **AZ88.40-P-0011-01ME**
9. Check anti-twist protection (**C, figure 3**) of cable lug of ground **point W2/6** for damage.

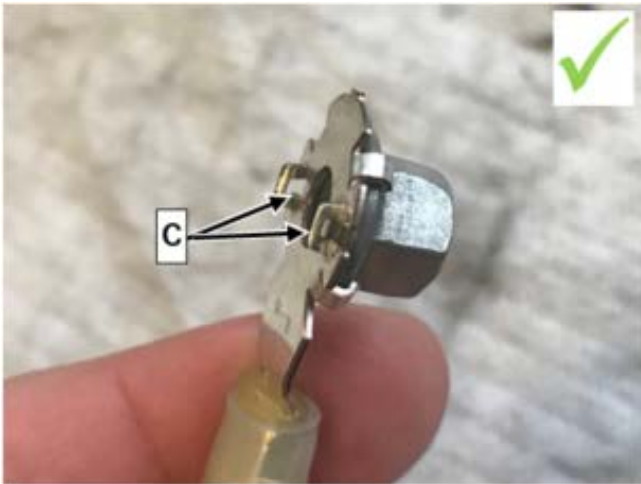
Figure 3 (OK)

- a. Anti-twist protection (**C, figure 3**) **straight** or **bent outwards**, i.e. outside dimension between anti-twist protection lugs (**D, figure 4**) **equal to or greater than 13.6 mm**: Perform operation step 11, then **end measure**.
- b. Anti-twist protection (**C, figure 3**) **bent inwards**, i.e. outside dimension between anti-twist protection lugs (**D, figure 4**) **less than 13.6 mm**: Create **PTSS case**.

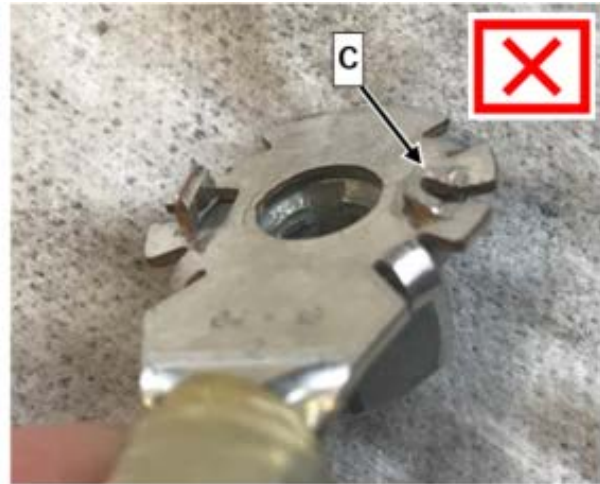
(not OK)

**i** Only if anti-twist protection of cable lug is **bent inwards** , i.e. outside dimension between anti-twist protection lugs (**D, figure 4**) is **less than 13.6 mm**.

Make detailed photos of anti-twist protection of ground line, ground point W2/6 in removed condition. Clarify the further repair procedure via a **PTSS case**. Keep faulty part.

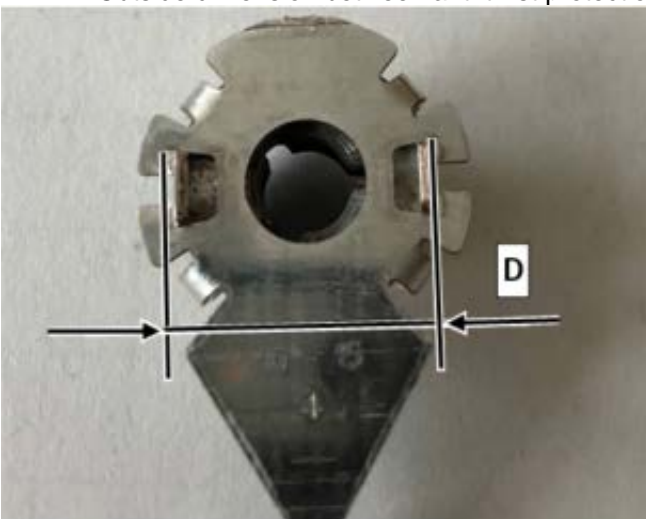
Figure 4

**i** Outside dimension between anti-twist protection lugs (**D, figure 4**) min. 13.6 mm.

10. Measure outside dimension between anti-twist protection lugs (**D, figure 4**).
