Safety Recall Code: 24Gi

Fuel Rail Bolts

March 31, 2021

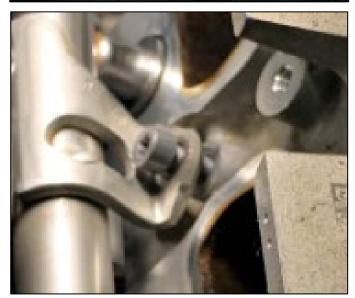
<u>Step 1</u> - Visual inspection for broken bolt, obviously loose bolts, exposed injector seal.

- Visually inspect all four fuel rail bolts for broken bolts or bolts that have backed out and are obviously loose <arrow A>.
- Visually inspect for signs that the fuel rail is pulling away from the cylinder head and exposing the fuel injector seal <arrow B>.
- If <u>any</u> of the four bolts are broken or loose, or a fuel injector seal is exposed:
 - The fuel rail and injectors must be replaced.
 - o Proceed to Section D.
- If all four bolts pass the first inspection, proceed to Inspection Step 2.

- Check for loose fuel rails bolts by hand, without using tools.
- All four fuel rail bolts must be checked.
- If <u>any</u> of the four bolts are loose:
 - The fuel rail and injectors must be replaced.
 - o Proceed to Section D.
- If all four bolts pass the second inspection, proceed to Inspection Step 3.

It may be possible that a fuel rail bolt is loose, but the pressure of a damaged fuel rail bracket prevents the bolt from be loosened by hand.

- If the feeler gauge passes between the cylinder head and fuel rail bracket and stops at the fuel rail bolt, this is evidence that the bolt has loosened (fig. 2).
- If any bolt fails the gap test:
 - The fuel rail and fuel injectors must be replaced.
 - Proceed to Section D.
- If the feeler gauge does not pass between the cylinder head and fuel rail bracket, the connection is OK (fig. 1). Move on to the next connection.
- If all four fuel rail bolts have passed all three inspection steps:
 - The fuel rail bolts must be replaced one at a time.
 - Proceed to the next step.
