# Keystone RV Company

## SAFETY ADVISORY # 20-389

### Cougar Inverter Wiring

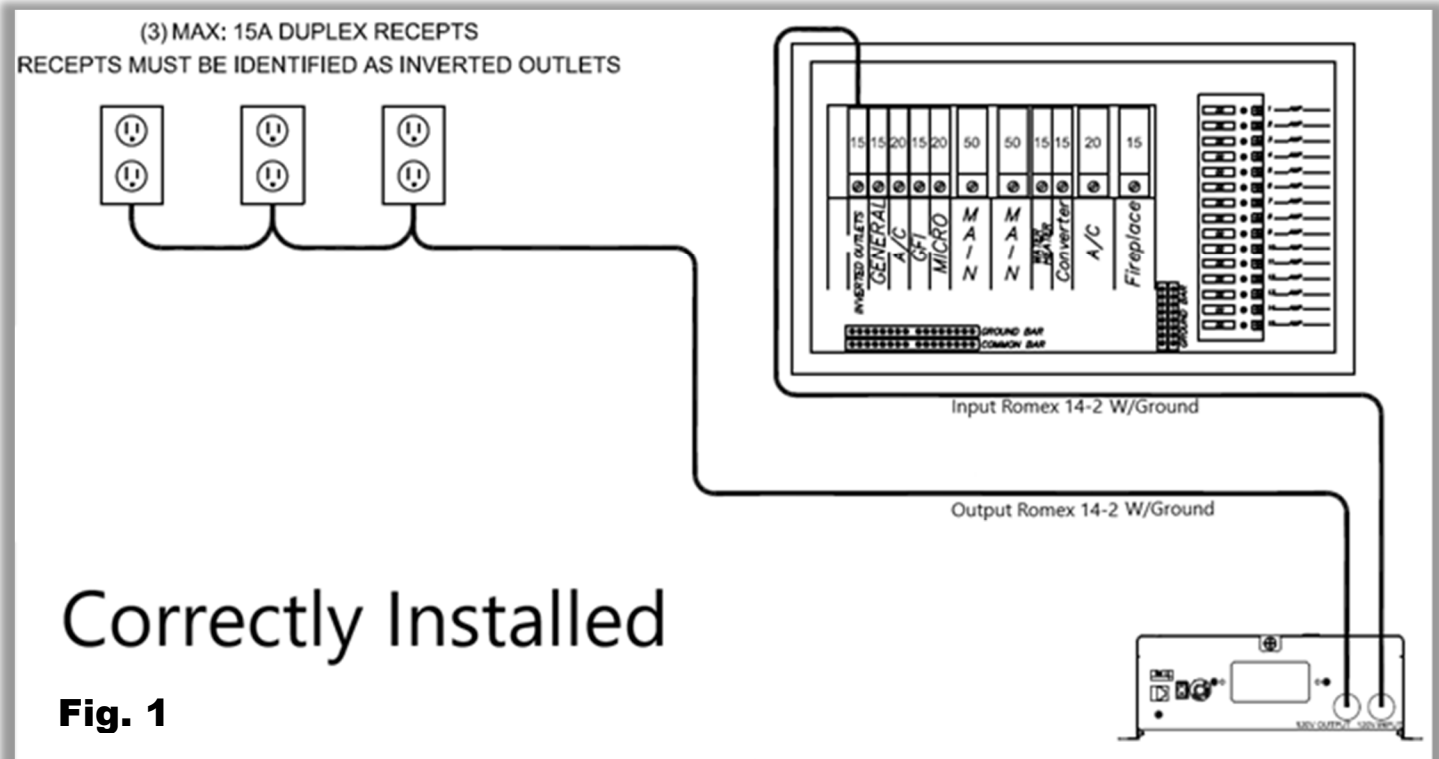
With a fully charged battery connected; disconnect the shore power and turn on the inverter. Inspect outlets labeled “Off the Grid Inverter Circuit”. These should be the only 120VAC circuits energized in the unit. See Figure 1. If these are the only circuits energized proceed to Warranty Reimbursement for inspection only, otherwise proceed to Step 3.

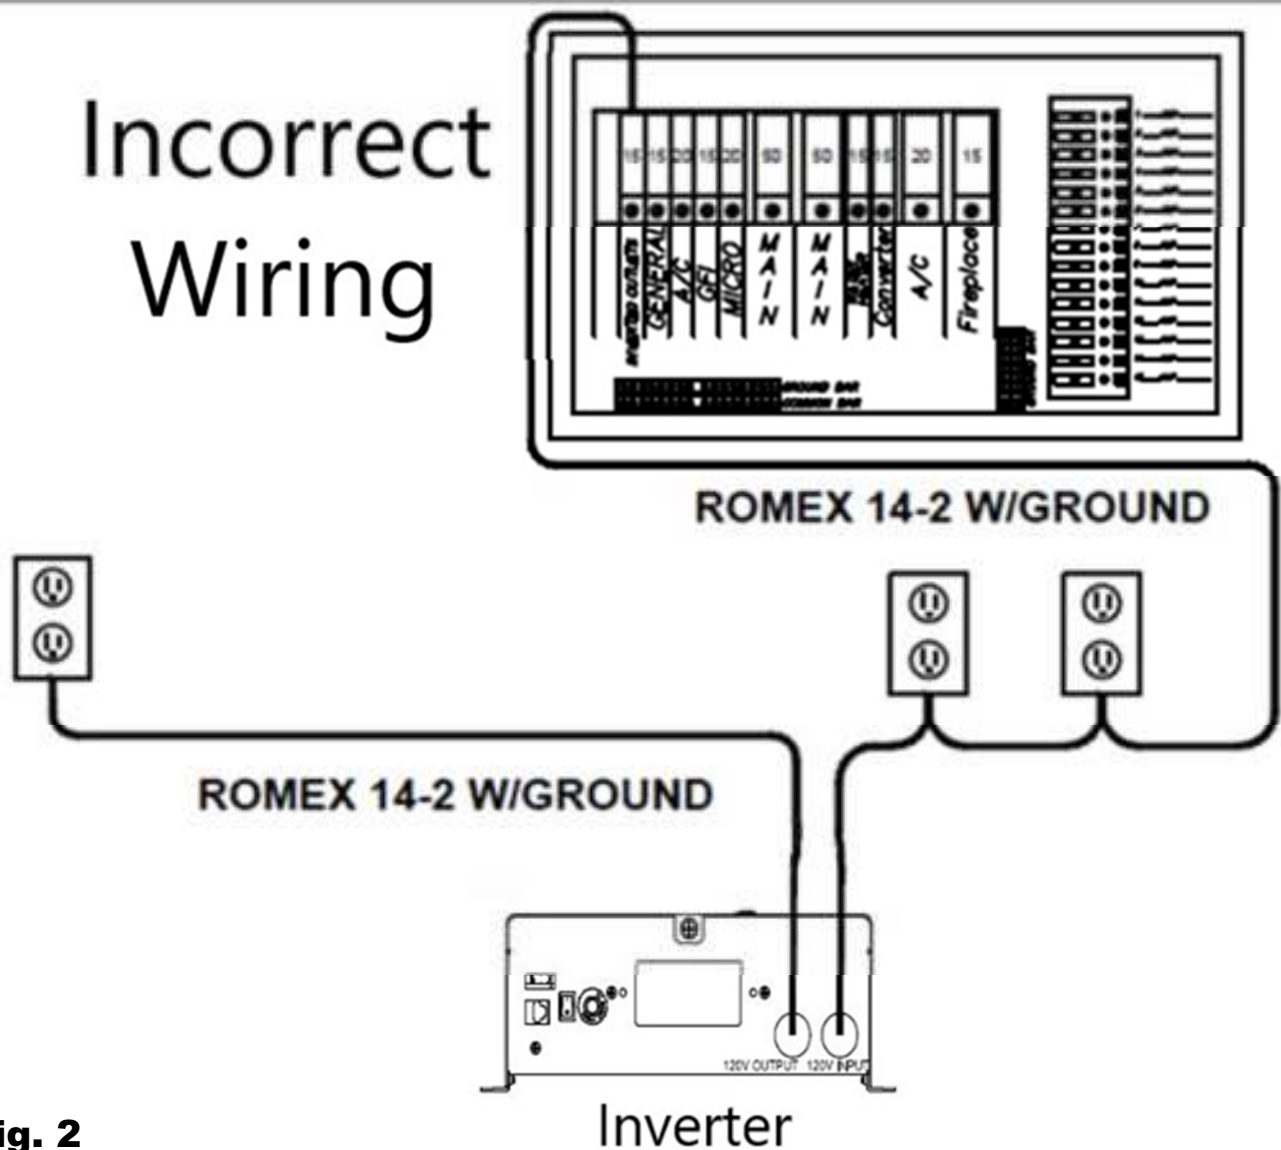
**Fig. 2**

Only West Coast units with Serial numbers starting with LCXXXXXX and MCXXXXXX are potentially affected by this scenario. If only one outlet labeled "Off the Grid Inverter Circuit" is energized See Figure 2. Disconnect the 120VAC power and the 12VDC power. Remove the power center and disconnect the wiring to the breaker labeled as "Inverter" along with the neutral and the bare copper wire for this circuit out of the power center.
