RECALL BULLETIN:
201109REV

Fleetwood
Bounder,
Discovery
Discovery LXE,
Pace Arrow,
Pace Arrow LXE
and Southwind
Holiday Rambler
Armada,
Endeavor,
Nautica,
Navigator, and
Vacationer

Lippert Bed Lift
Motor Recall

EUROLOFT™ BED LIFT MOTOR REPLACEMENT

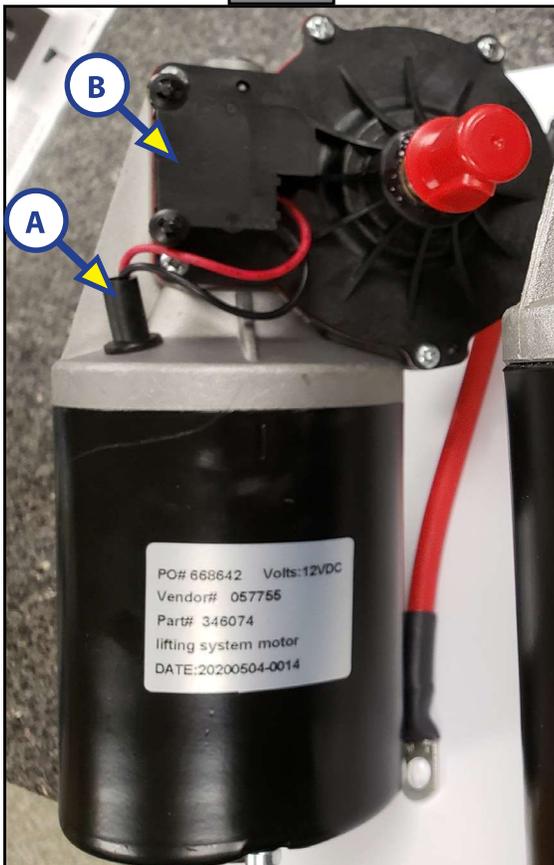
Fig. 1

Select motors (PN 346074) received from an LCI supplier have the potential for primary gear failure, allowing for the possibility of the bed frame to drop a short distance before the safety strap catches the bed frame assembly. This document will describe the process of removing a defective motor and replacing it with a new motor.

NOTE: OLD defective motors (Fig.1) have red and black wires (Fig.1A) exiting the motor, and no LCI logo on the plastic casing of the gear box cover (Fig.1B). NEW replacement motors (Fig.2) will have green and black wires (Fig.2A) exiting the motor, and a molded LCI logo on the plastic gear box cover (Fig.2B).
