<b>Tesla, Inc.</b> Service Bulletin		<b><i>Inspect Front Roof Applique &amp; Center Spine Applique For Lack of Adhesion</i></b>	
SB-20-12-005 December 23, 2020		R1			
<b>Classification</b>		<b>Section/Group</b>		<b>Mobile Service</b>	
Recall Bulletin		12 - Exterior Fittings		Can Perform (where permitted)	
<b>Model Year</b>	<b>Model</b>	<b>Country/Region</b>		<b>Version</b>	
2016	Model X	All		All	
The model(s) and model year(s) listed are a general approximation of the affected VIN list. Refer to the VIN/Bulletin Tracker or Customer/Vehicle profile to determine applicability of this bulletin for a particular vehicle.

On certain Model X vehicles, the front roof applique and/or center spine applique may have been applied to the roof without the use of primer, which could cause the applique(s) to separate from the roof.

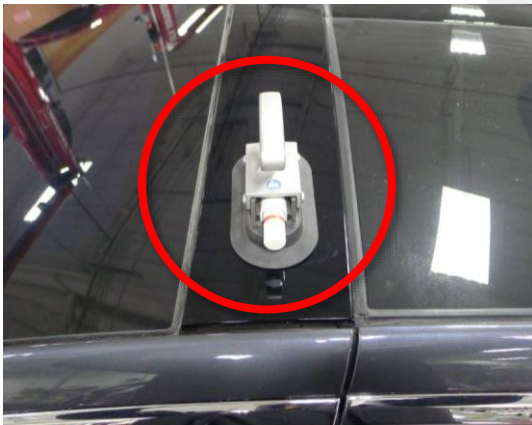
Figure 1 – Vacuum cup for Service Centers

1. Clean the front roof applique to ensure that its surface is free of dirt or debris.
2. Secure the vacuum cup onto the LH outboard end of the front roof applique (Figures 1 and 2).

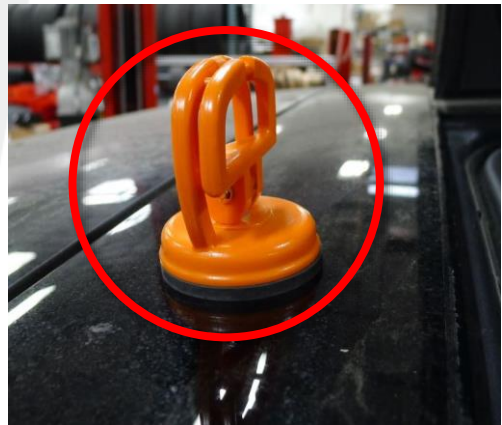
Figure 2 – Vacuum cup for Mobile Service

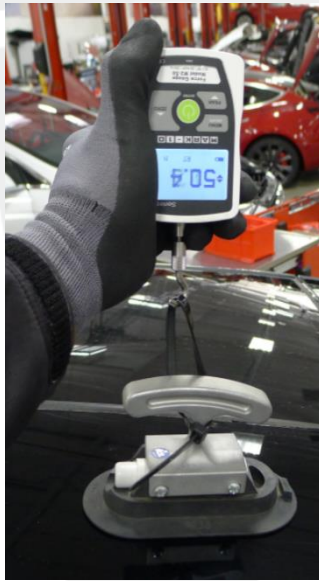
**Figure 3**

3. Connect the vacuum cup to the force gauge, and then pull up slowly on the vacuum cup with 60 N maximum force (50 N for Mobile Service) (Figure 3). Inspect the front roof applique for the following:

- If the front roof applique separates from the roof **AND** the front roof applique is damaged, replace the front roof applique (refer to Service Manual procedure [12206002](#)), and then skip to step 6.
- If the front roof applique separates from the roof **AND** the front roof applique is undamaged, remove the front roof applique, remove the old sealant from the front roof applique, reinstall the front roof applique (refer to Service Manual procedure [12206002](#)), and then skip to step 6.
- If the front roof applique stays sealed on the roof, the front roof applique adhesion is in good condition. Continue to the next step.

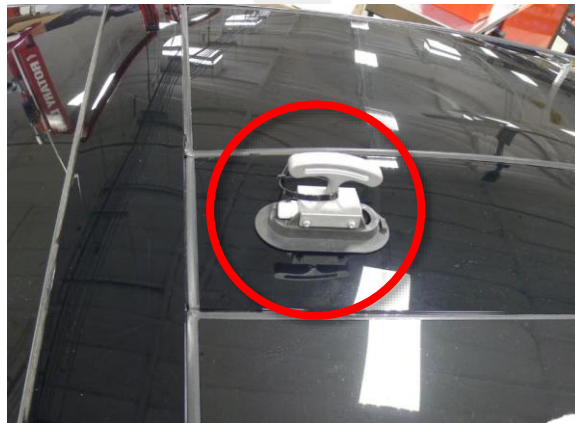
**Figure 4 – Shown with vacuum cup for Service Centers; Mobile Service similar**

4. Remove the vacuum cup from the front roof applique.
5. Repeat steps 2, 3, and 4 on the center and the RH outboard end of the front roof applique.
6. Clean the center spine applique to ensure that its surface is free of dirt or debris.
7. Secure the vacuum cup onto the front end of the center spine applique (Figure 4).

8. Connect the vacuum cup to the force gauge, and then pull up slowly on the vacuum cup with 60 N maximum force (50 N for Mobile Service). Inspect the center spine applique for the following:

- If the center spine applique separates from the roof, replace the center spine applique (refer to Service Manual procedure [10403002](#)), and then skip to step 11.
- If the center spine applique stays sealed on the roof, continue to the next step.

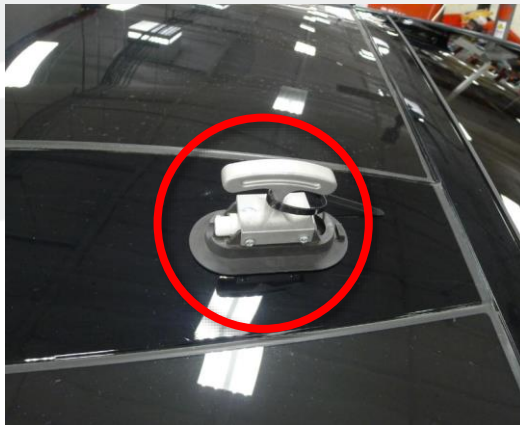
**Figure 5 – Shown with vacuum cup for Service Centers; Mobile Service similar**

10. Repeat steps 7, 8, and 9 on the rear end of the center spine applique (Figure 5).
