Safety Recall

Code: 40Q6

Subject Steering Knuckle(s) – STOP DRIVE

Release Date December 16, 2020

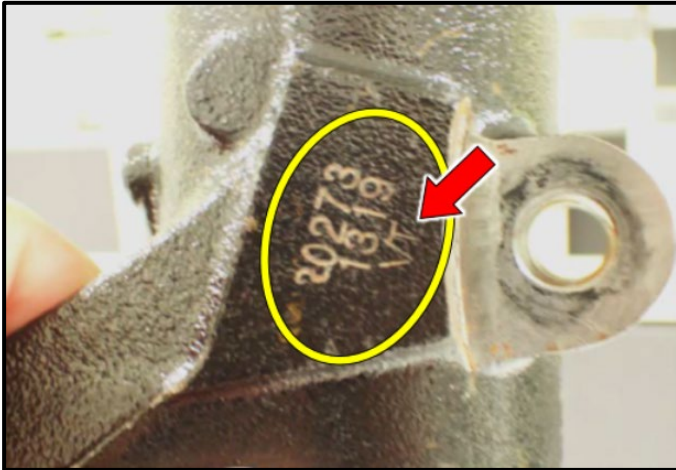
Section B – Wheel Bearing Housing Inspection

- Raise vehicle on hoist.
- Locate the production stamping on the wheel bearing housing <circle>.
- If the manufacturer code “VT” is NOT present on both wheel bearing housings:
 - No further work is required.
 - Proceed to Section D.
- If the manufacturer code “VT” IS present on either wheel bearing housing:
 - **THE VEHICLE MUST NOT BE RETURNED TO THE CUSTOMER OR DRIVEN!!**
 - The affected wheel bearing housing must be replaced.
 - Proceed to Section C.
