TECHNICAL INSTRUCTIONS
FOR
20TA17
STEERING COLUMN ISSUE MAY AFFECT AIRBAG PERFORMANCE
CERTAIN 2020 – 2021 AVALON
CERTAIN 2020 AVALON HYBRID

A component of the steering column on the subject vehicles may have been damaged during assembly. This can potentially affect the performance of the driver airbag when it deploys. This may cause the vehicles not to meet certain federal safety requirements and can result in an increased risk of injury during a crash necessitating airbag deployment.

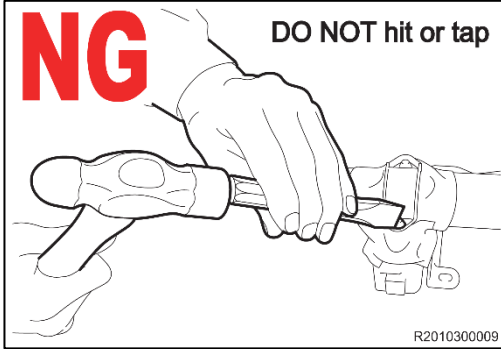
DO NOT hit or tap the steering lock actuator bolt to remove.
Shock applied to the steering lock actuator assembly may cause the actuator to malfunction.
