Safety Recall

Code: 97EU

Subject	Rear Light Wiring Harness Scuff Protection																														
Release Date	January 20, 2021																														
REVISION SUMMARY	Updated parts and claiming information to reflect updated length of roll of tape, part number N -107-515-03																														
Affected Vehicles

Subject: Safety Recall 97EU - Rear Light Wiring Harness Scuff Protection

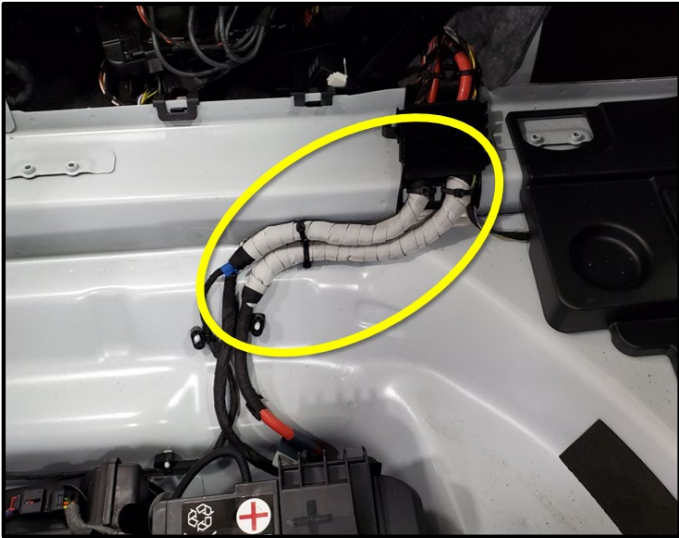
Repair Overview

What is the issue? Scuff protection for the rear lights wiring harness in the area of the spare wheel well was not installed during production as required. In case of a rear crash, it may be possible for the affected wiring to be damaged and power supply of the vehicle may become compromised. This could result in it not being possible to open the vehicle doors from the outside, or the hazard warning lights may not function. This may lead to an increased risk of injury to vehicle occupants in case of a rear crash.

- Install protective tape on trunk wiring harness.
