GROUP	NUMBER
RECALL	21-01-022H-1
DATE	MODEL(S)
DECEMBER 2021	APPLICABLE VEHICLES BELOW

ENGINE INSPECTION / REPLACEMENT (RECALL CAMPAIGN 198)

This TSB supersedes TSB# 21-01-022H to revise the Warranty Information and Service Procedure.

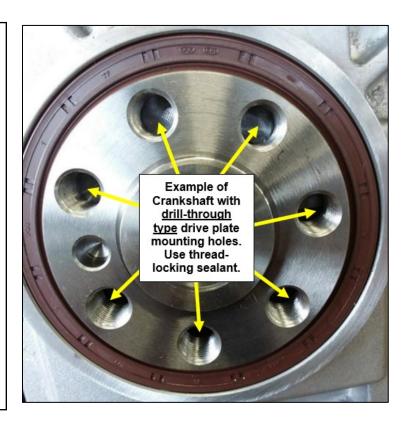
Certain types of engines may have crankshaft with drill-through type drive plate mounting holes. Apply thread-locking sealant to prevent any oil seepage through the drive plate bolts.

Apply on all threads a low/medium strength thread-locking adhesive that seals fasteners and are tolerant to engine oil.

Be sure to lightly brush all the bolt threads free of debris/residue and clean off any oil prior to applying the thread-locking sealant for installation.

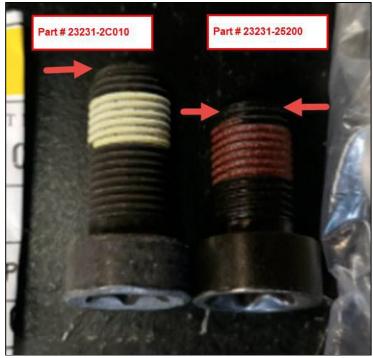
For 11-12MY Sonata Hybrid (YF HEV):

- ❖ Due to changes to the crankshaft design, the existing bolts are ~2mm too long and will result in improperly fastened drive plate if reused.
- ❖ The 13-15MY version drive plate bolts (P/N 23231-25200) are correct length for the new engine and will provide proper fastening during engine installation.

When installing a new engine, the drive plate bolts must be replaced with P/N 23231-25200.
