## **Vehicle Safety Recall - Technical Service Bulletin**

**Attention:** McNeilus Product Owner  
**Subject:** Bridgemaster Pressure Placard  
**Models Affected:** Bridgemaster Mixer  
**Model Year:** 2020  
**Date:** December 2020

## PROCEDURE: Pressure placard replacement

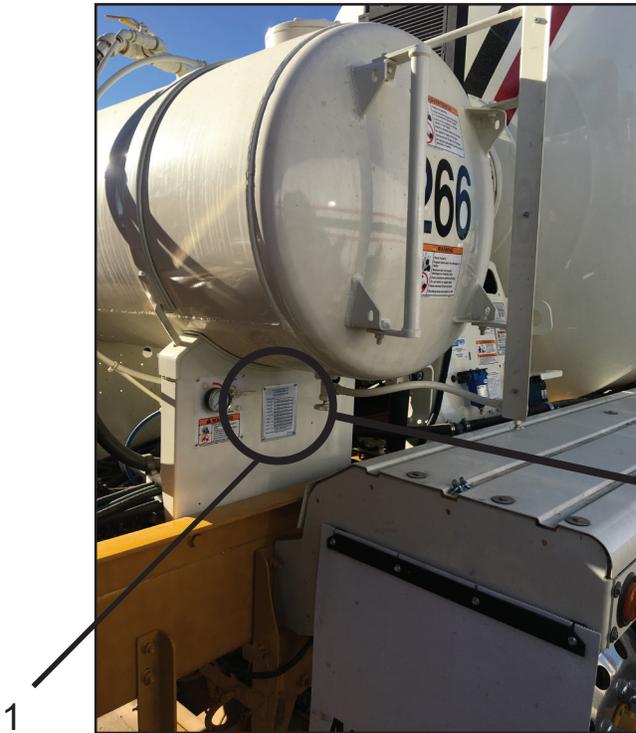
Figure 1

McNeilus Truck and Manufacturing, Inc. has decided that a concern affecting safety exists in some McNeilus Bridgemaster V concrete mixers. Certain Bridgemaster mixers may have received an incompletely stamped information plate. The missing information is when the auxiliary axles are required to be in the down/up position under certain loads. Without this information, the user may not be able to safely operate the mixer.

1. Locate placard (typical location is on the water tank saddle. See image 1, Item 1 below).
2. Drill out the rivets on the current placard (5/32 drill bit). Remove and discard the placard.
3. Hold the new placard up to the location of the old placard. Using a machinist's marker, mark the three new, additional holes using the new placard as a template.
4. Drill out the three new holes (11/64 drill bit).
5. Using a blind rivet tool, install the new placard with new rivets (Figure 2). Install rivets in the three new holes as well as one of the original holes.
