# RECALL CAMPAIGN BULLETIN

Classification: EC20-029A	Reference: NTB20-089A	Date: April, 13 2021
------------------------------	--------------------------	-------------------------

## VOLUNTARY SAFETY/EMISSION RECALL CAMPAIGN 2020 TITAN AND TITAN XD; EGI HARNESS

**CAMPAIGN ID #:** PC773  
**APPLIED VEHICLES:** 2020 Titan and Titan XD (A61)  
**APPLIED ENGINE:** VK56VD (Gasoline V8)

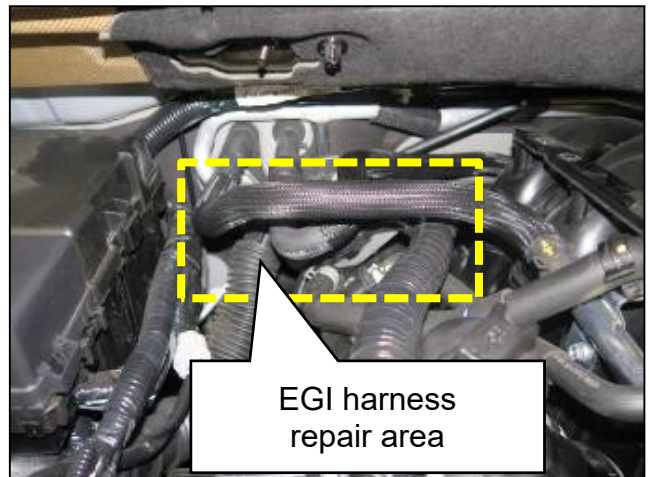
Figure 6

**NOTE:** The EGI harness repair will be performed toward the back of the passenger side valve cover, as shown in Figure 6.

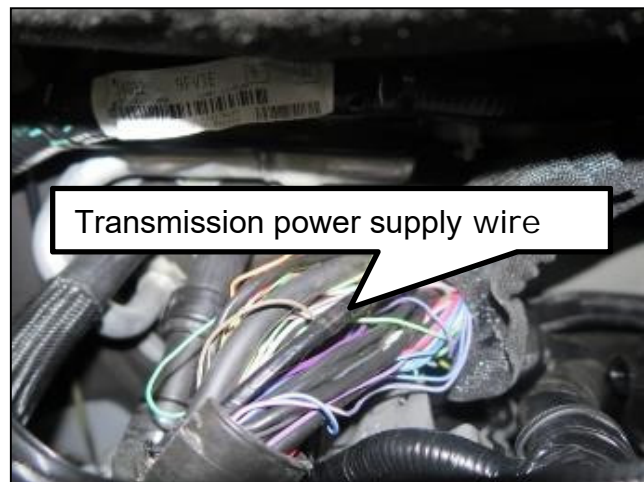
Figure 18

- Identify the transmission power supply wire for repair.

- The transmission power supply wire is located near the center of the EGI harness.
- The transmission power supply wire is completely wrapped with vinyl tape.

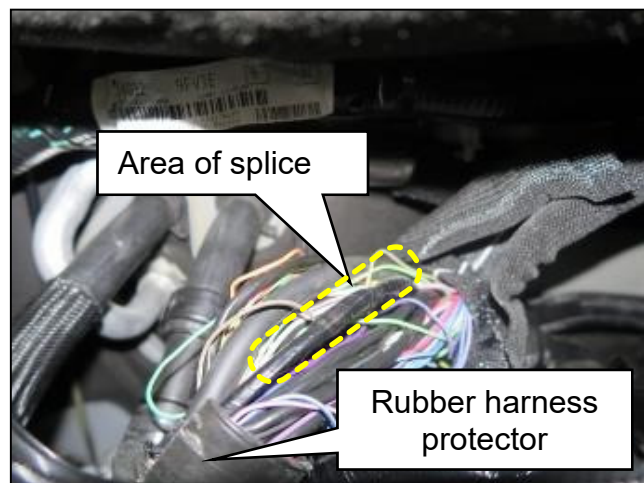
Figure 19

- Locate the affected splice within the transmission power supply wire.

- The splice will be located near the large harness retaining clip.
- The splice can be located by feeling for a raised section on the wire.
