SIB 12 12 20

RECALL 20V-761: CHECK 48 V CABLE CONNECTIONS TO THE STARTER GENERATOR (SGR)

This Service Information Bulletin (Revision 2) replaces SI B12 12 20 **dated December 2020**.

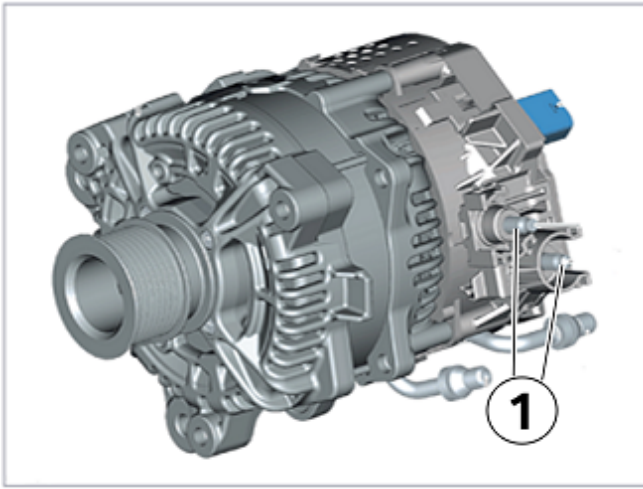
The 48-Volt battery cable connections to the starter / generator (SGR) may not have been assembled to specifications. Over time, this could lead to increased resistance at the connection(s) and, in rare cases, a thermal event.

Check the positive (1) and negative (2) cables for play at the mounting lugs on the SGR.

- Deactivate the 48 V electrical system (Repair instruction REP-TAT-P-6124-18-B47_48V)
- Remove and discard the flange nut on the B+ or B- cable.
- Install a new flange nut so that it's carefully started by hand to avoid cross-threading
- Torque to 19 Nm
