**PRODUCT CAMPAIGN BULLETIN**

**APPLICABILITY:** 2020MY Legacy and Outback

**NUMBER:** WRH-20R

**SUBJECT:** Rear Visibility FMVSS 111 Non-Compliance

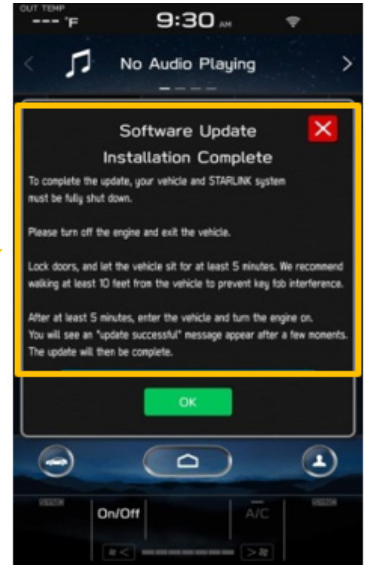
- Clarification of the post-FOTA procedure instructions required to complete the update. The screenshot below will appear and explain what must be done to complete the update installation.

**Software Update Installation Complete**  
To complete the update, your vehicle and STARLINK system must be fully shut down. Please turn off the engine and exit the vehicle. Lock doors, and let the vehicle sit for at least 5 minutes. It is recommended to walk at least 10 feet from the vehicle to prevent key fob interference. After waiting at least 5 minutes, enter the vehicle and turn the engine on. An "Update Successful" message will appear after a few moments. The update will then be complete.

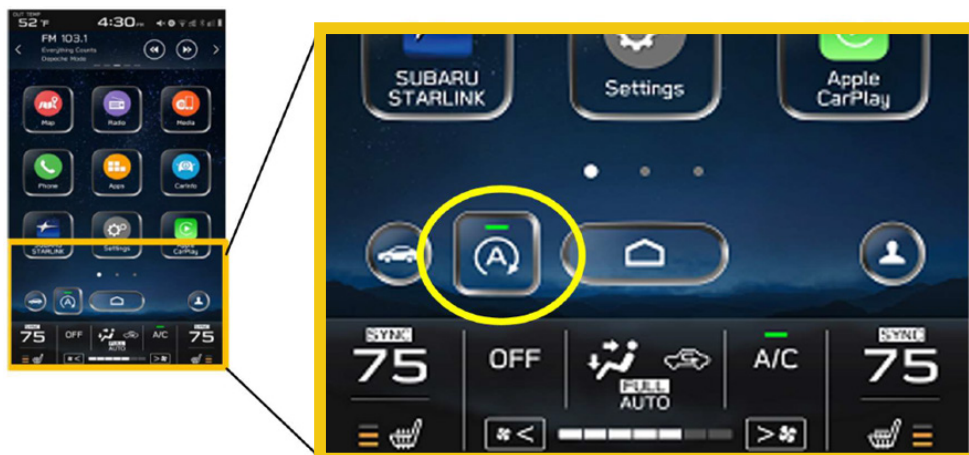
The Auto Stop-Start On/Off function button has been moved from the bottom to top layer of the system for easier use. A screenshot of how the button will appear is shown below.

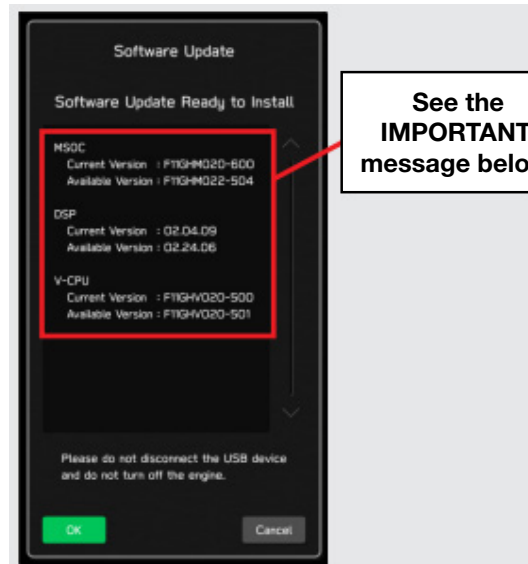
6f) The screen below will be displayed. **NOTE:** The actual software version displayed will be different from the EXAMPLE picture shown below.

**IMPORTANT:** The example above identifies the head unit model and the last 6 digits signify the software version number. Examples:

**Confirm the MSOC Available Version listed here matches with what is shown on the CID.**

**If it does not match the Available Version shown on the CID Screen STOP and load the correct file to the USB Drive.**

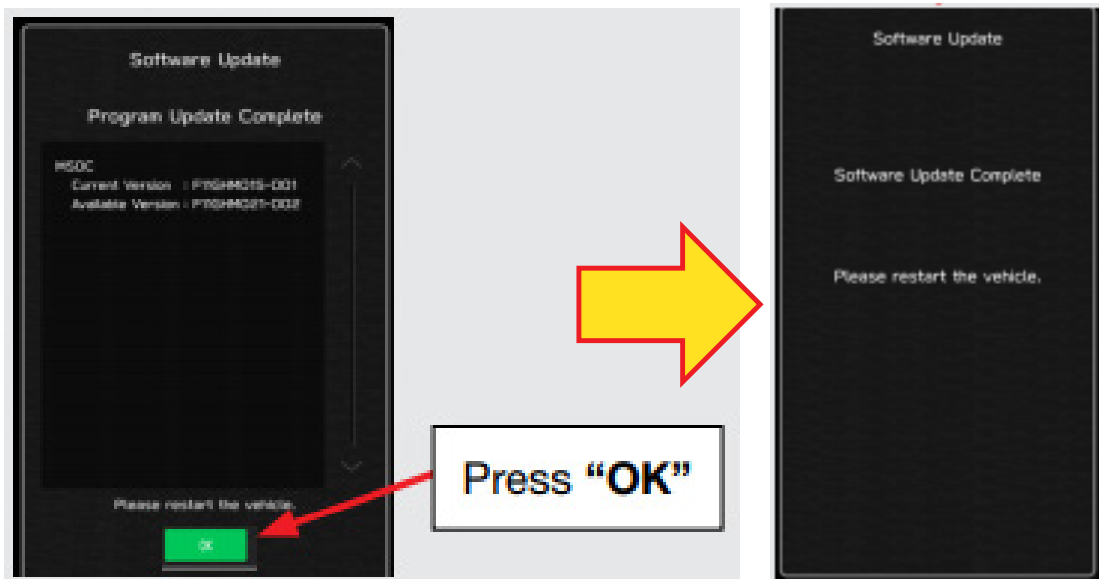
**6h)** When the update is complete, the screen below will be displayed (the actual software version number will be different).

**IMPORTANT NOTE:** On rare occasions a “Software Update Incomplete” message may appear in this step which occurs due to a bug in the software update procedure. **DO NOT** attempt to install the update again, proceed to **6i)** below to confirm the software version has been updated to the latest version.

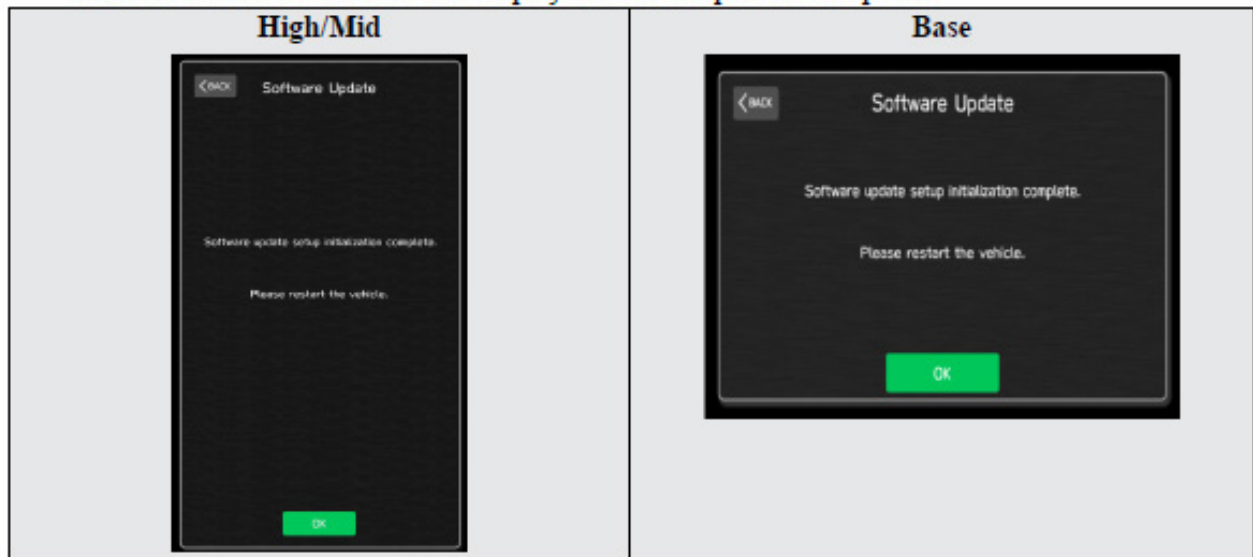
- The screens shown below will be displayed when the process completes.

1. Turn the ignition OFF, open the driver's door, close the driver's door and **WAIT** for 3 or more minutes before proceeding further.
2. Open the driver's door again and either turn the ignition ON (if a charger is connected) or start the engine.
3. Go to Dealership Mode menu again (PRESS and HOLD the RIGHT-side temperature control buttons (both up and down) and press the Tune / Scroll knob 6 times then release all to display the Dealership Mode) and select Software Update as in STEP 3 beginning on pg. 8.

**IMPORTANT NOTE:** If this procedure is required, contact Techline as additional action may be necessary.
