PRODUCT CAMPAIGN BULLETIN

APPLICABILITY: 2020MY Legacy and Outback

NUMBER: WRH-20

SUBJECT: Rear Visibility FMVSS 111 Non-Compliance

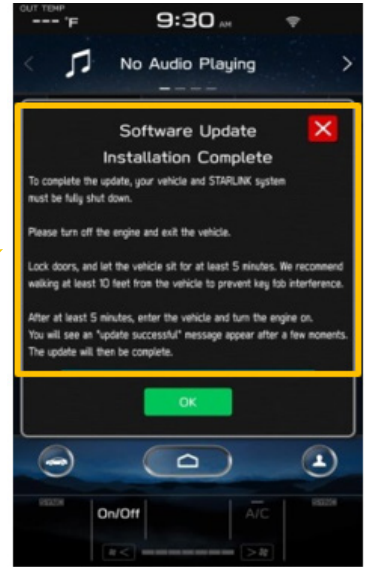
- Clarification of the post-FOTA procedure instructions required to complete the update. The screenshot below will appear and explain what must be done to complete the update installation.

Software Update Installation Complete
To complete the update, your vehicle and STARLINK system must be fully shut down. Please turn off the engine and exit the vehicle. Lock doors, and let the vehicle sit for at least 5 minutes. It is recommended to walk at least 10 feet from the vehicle to prevent key fob interference. After waiting at least 5 minutes, enter the vehicle and turn the engine on. An "Update Successful" message will appear after a few moments. The update will then be complete.

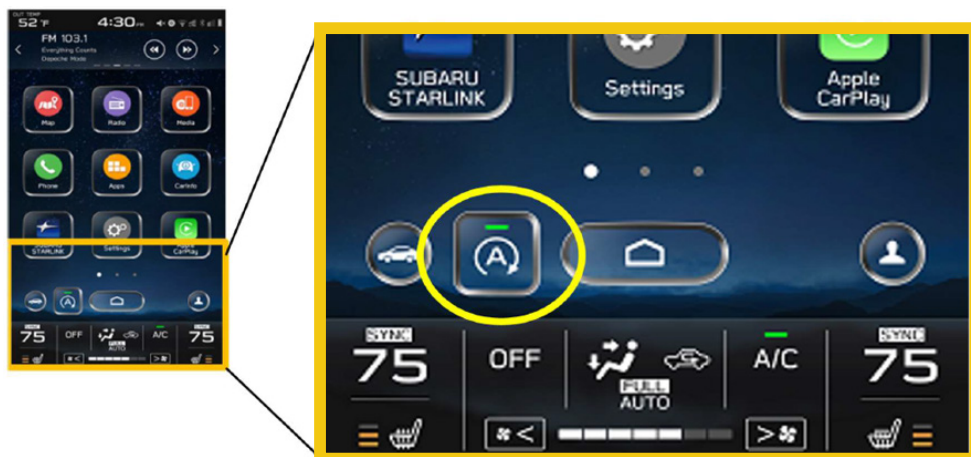
The Auto Stop-Start On/Off function button has been moved from the bottom to top layer of the system for easier use. A screenshot of how the button will appear is shown below.

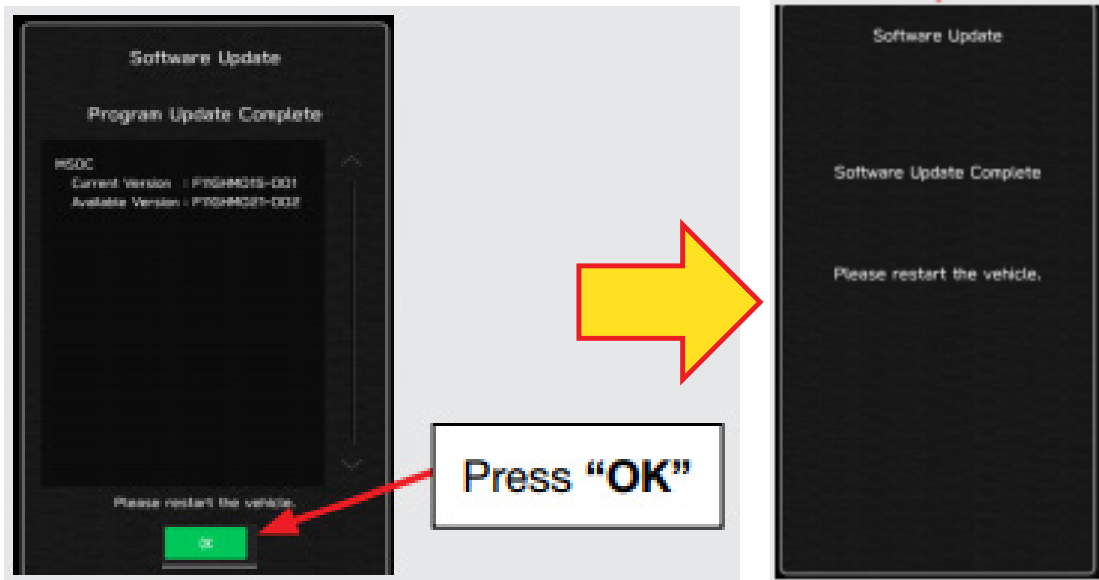
6h) When the update is complete, the screen below will be displayed (the actual software version number will be different).

IMPORTANT NOTE: On rare occasions a “Software Update Incomplete” message may appear in this step which occurs due to a bug in the software update procedure. DO NOT attempt to install the update again, proceed to **6i)** below to confirm the software version has been updated to the latest version.

- 6i)** Select OK in the screen above then remove the H/U reprogramming USB from the USB port.
- 6j)** Turn the ignition OFF, open the driver’s door then close the driver’s door.
- 6k)** Wait for at least 3 minutes, then turn the ignition ON.
- 6l)** Access Dealership Mode following steps provided in **6b)** above and confirm the software update completed successfully using the table below:
