PRODUCT CAMPAIGN BULLETIN

APPLICABILITY: 2020MY Legacy and Outback **NUMBER:** WRH-20R
SUBJECT: Rear Visibility FMVSS 111 Non-Compliance **DATE:** 12/11/20
REVISED: 12/15/20
NHTSA ID: 20V-766

INTRODUCTION:

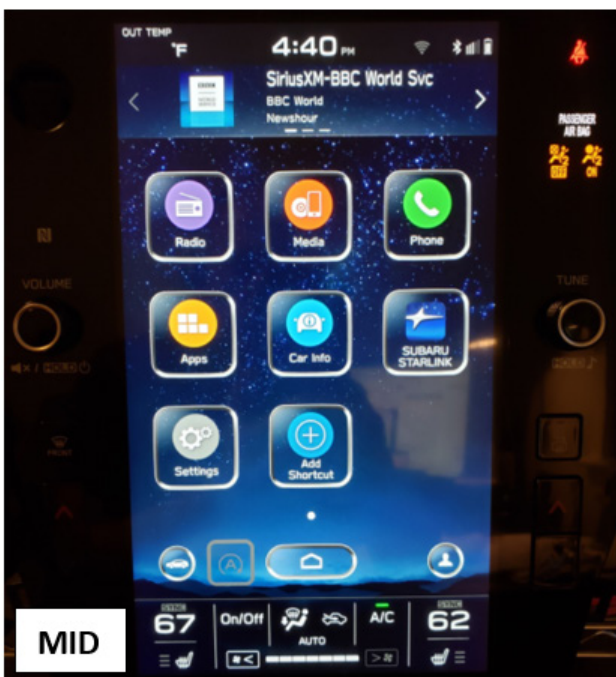
This Campaign affects certain “Mid” and “High” (w/ Navigation) -level CP1 Head Units with 11.6-inch display ONLY as pictured below. The “Base” model (2- 7.0-inch display screen unit) is NOT affected.

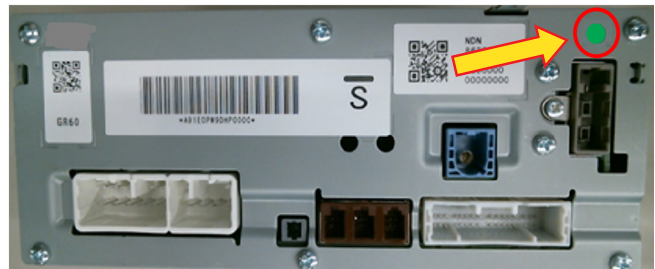
STEP 2a: When receiving the exchange CCM, inspect the back of the module for a GREEN dot as shown here. This **GREEN** dot signifies the module has already been updated with the latest Version 4.0 software. **NOTE:** All related CCMs shipped to retailers after 12/3/2020 have this dot. The **GREEN** dot will be applied to related exchange modules for six months. After that time, the dot will be discontinued but the modules will be OK for use. Proceed with CCM R&R following the procedure in the applicable Service Manual.

- Always record the serial number of the exchange CCM being installed on the Repair Order (RO).
- Confirm and record the software version number installed in the exchange CCM on the RO. See **STEP 3** for instructions.
- After CCM replacement, ALWAYS confirm proper back-up camera operation before releasing the vehicle.
