Safety Recall Code: 69BC

| | | | | | REVISION |
|---|--|--|---|---|---|
| Subject | Driver Frontal Airbag | | | | |
| Release Date | December 9 | , 2022 | | | |

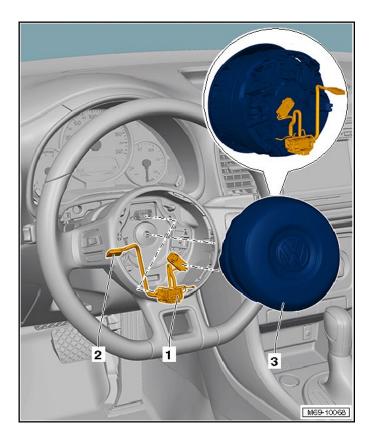
Repair Overview

| What is the issue? | The driver's side air bag inflator may explode due to propellant degradation occurring after long-term exposure to high absolute humidity, high temperatures, and high temperature cycling. An inflator explosion may result in sharp metal fragments striking the driver or other occupants resulting in serious injury or death. |

Replace driver frontal airbag.

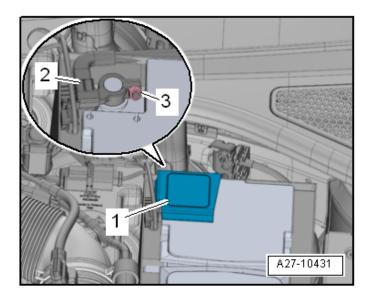
Disconnect the 12V battery with the ignition switched ON:

Accident risk. When working on pyrotechnic components (such as airbags and belt tensioners), the battery must be disconnected with the ignition switched **ON**.

- Turn **ON** the ignition.
- Access the battery.
- Loosen the nut <3>.
- Remove and isolate the battery ground cable <2> from the battery terminal.

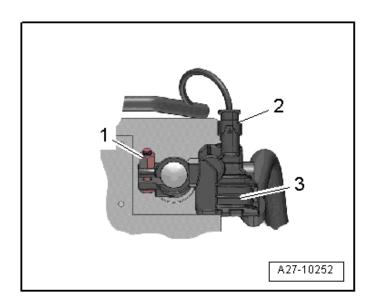
Reconnect 12V battery:

Ignition must be **ON** when connecting battery. If pyrotechnic components (e.g. airbag, belt tensioner) are not repaired correctly, they may deploy unintentionally after connecting battery. There must not be anyone inside the vehicle when connecting the battery.

- Disconnect the connector <2> from the Battery Monitoring Control Module -J367- <3> (if equipped).
- Attach the battery ground cable clamp by hand to the battery negative terminal and torque the nut <1> to 6 Nm.
- Reconnect the connector to the Battery Monitoring Control Module -J367- (if equipped).
- Cycle the ignition off and back on.
- Set clock to local time.
- Activate the convenience open/close functions.
- Check the DTC memories of all the control units and erase under-voltage faults if necessary.
