IMPORTANT SAFETY RECALL NOTICE
NHTSA Recall Number: 20V-125 School Bus

SUBJECT: FMVSS 222 Noncompliance Seat Barrier Install Behind Driver Seat Integrated 3-Point Seatbelt

R20AM Seat Barrier Install Behind Driver Seat Integrated 3-Point Seatbelt

Models Affected: 2008 through 2021 Model Year All American and Vision Buses

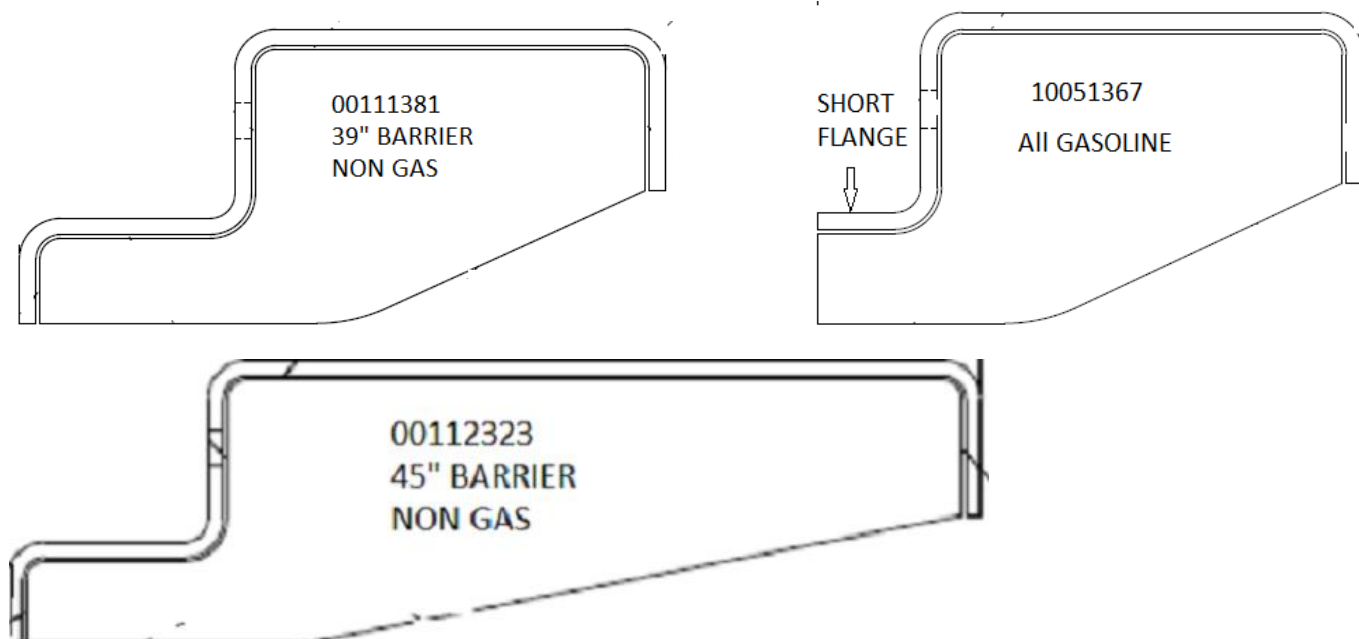
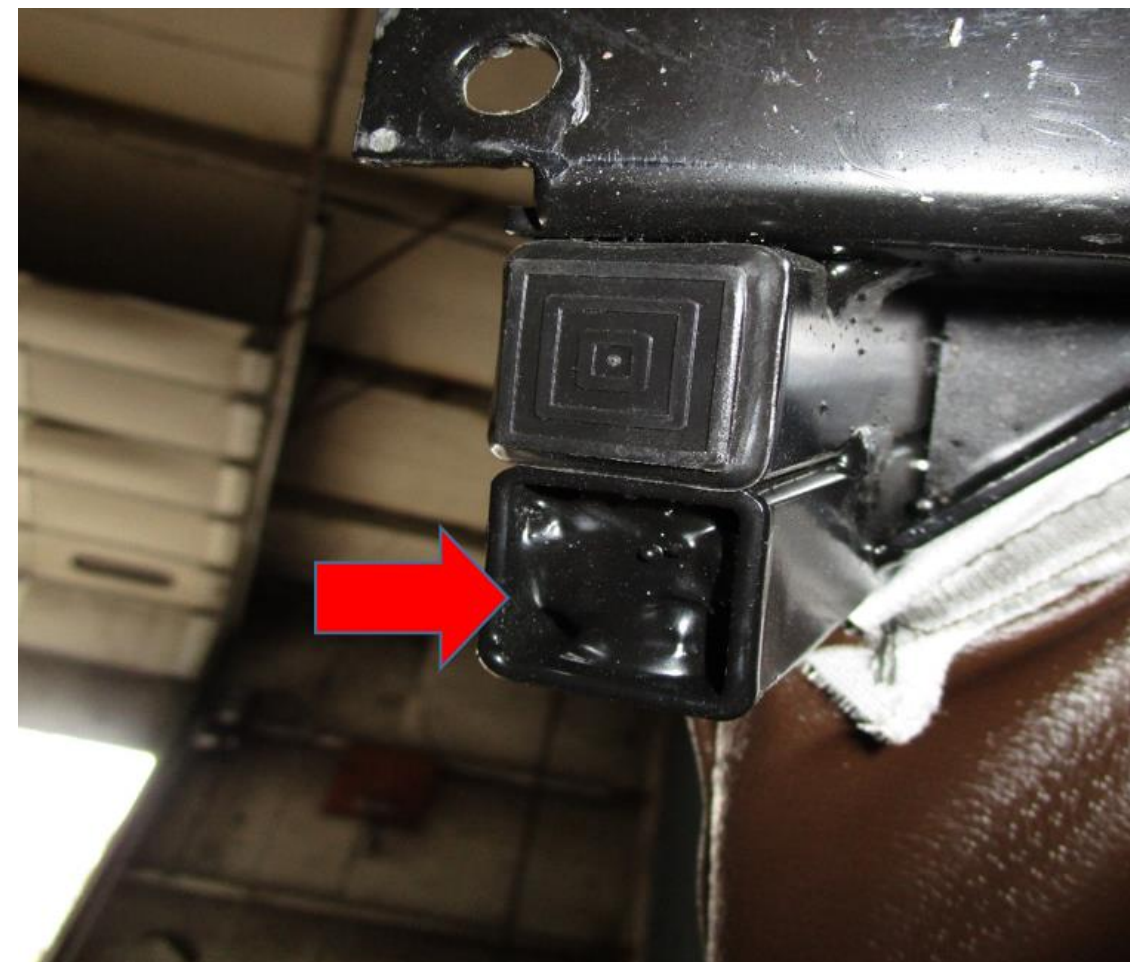
Photo 1

Ensure the correct barrier is installed. Do this by visually inspecting the underside of the barrier frame at the wall bracket. If the inside frame tubing is hollow it is the incorrect barrier and will need to be changed. If the inside barrier tubing is solid the barrier is correct as the reinforcement has been welded into place. **See Photo (1)**
