R20AW

Subject: R20AW – Drag Link Castle Nut Torque Confirmation

#### **IMPORTANT SAFETY RECALL NOTICE**

# **R20AW Drag Link Castle Nut Torque**

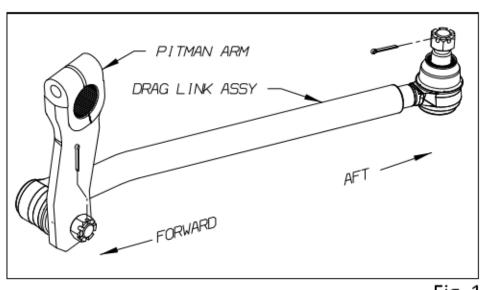
Fig. 1

Issue: The castle nuts on both ends of the drag link assembly may not have been installed according to manufacturer's installation specifications.

- 1. Park bus on a level surface, apply parking brake, switch engine off, remove ignition key and chock wheels.
- 2. Remove cotter pin from ball stud on forward (pitman arm) end of drag link. (Fig. 1)
- 3. Torque castle nut on drag link ball stud to 120 ft-lbs.
- 4. Remove cotter pin from ball stud on aft (steer arm) end of drag link. (Fig. 1)
- 5. Torque castle nut on drag link ball stud to 120 ft-lbs.
- 6. Install cotter pins.
- 7. If castle nut slot for cotter pin does not line up with through hole in each ball stud, tighten castle nut until next slot aligns with through hole. Install cotter pin and bend-over pin tails. WARNING: Do NOT loosen castle nut to line up slot with through hole in ball stud. Always tighten castle nut to align slot with through hole.
