NHTSA Recall Number: 20V-356 School Bus NHTSA Recall Number: 20V-357 Non-School Bus

DATE: July 27, 2020

SUBJECT: R20AW – Drag Link Castle Nut Torque Confirmation

R20AW Drag Link Castle Nut Torque

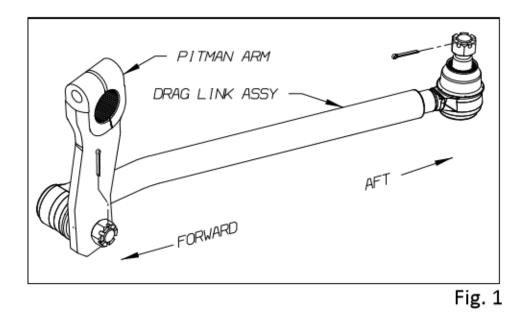
Issue: The castle nuts on both ends of the drag link assembly may not have been installed according to manufacturer's installation specifications.

- 1. Park bus on a level surface, apply parking brake, switch engine off, remove ignition key and chock wheels.
- 2. Remove cotter pin from ball stud on forward (pitman arm) end of drag link. (Fig. 1)
- 3. Torque castle nut on drag link ball stud to 120 ft-lbs.
- 4. Remove cotter pin from ball stud on aft (steer arm) end of drag link. (Fig. 1)
- 5. Torque castle nut on drag link ball stud to 120 ft-lbs.
- 6. Install cotter pins.
- 7. If castle nut slot for cotter pin does not line up with through hole in each ball stud, tighten castle nut until next slot aligns with through hole. Install cotter pin and bendover pin tails. WARNING: Do NOT loosen castle nut to line up slot with through hole in ball stud. Always tighten castle nut to align slot with through hole.
