R20AY

**DATE:** January 20, 2022  
**TO:** Blue Bird Owners  
**Subject:** R20AY – Steering Wheel Nut Torque Confirmation

**IMPORTANT SAFETY RECALL NOTICE**

## R20AY – Steering Wheel Nut Torque Confirmation

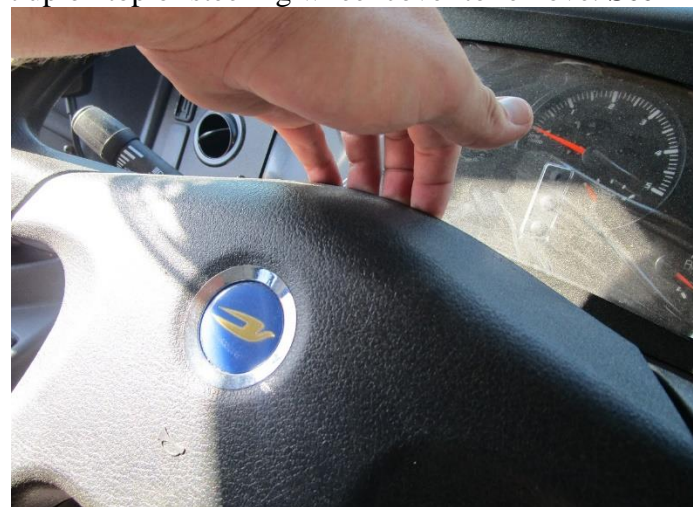
Photo 1

1. Lift up on top of steering wheel cover to remove. See Photo (1)
