R20AY

**DATE:** January 28, 2021  
**TO:** Blue Bird Owners  
**Subject:** R20AY – Steering Wheel Nut Torque Confirmation

**NHTSA Recall Number: 20V-456 School Bus**  
**NHTSA Recall Number: 20V-455 Non-School Bus**

## R20AY – Steering Wheel Nut Torque Confirmation

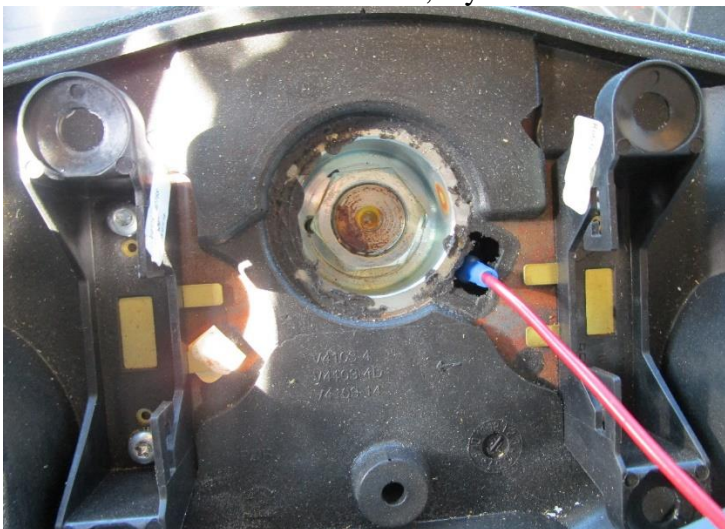
2. The cover contains the horn wire, lay the cover to the bottom.

3. Torque the steering wheel nut to 40-50ft lbs.
4. Ensure the horn wire is securely connected, then reinstall the steering wheel cover by pressing bottom portion in first followed by top of steering wheel cover until secure.
