# Product Safety Recall

## N192285070 Tonneau Cover Retention

Release Date: June 2020

<b>Condition</b>	General Motors has decided that a defect, which relates to motor vehicle safety, exists in certain tri-fold tonneau covers sold as accessories for 2019 – 2020 model year Chevrolet Silverado and GMC Sierra 1500 series trucks. The tonneau cover may become loose and could detach from the pickup bed while driving. <b>This recall includes all of the tri-fold tonneau covers previously subject to equipment recall 19E031 (N192217500).</b> If the tonneau cover is improperly installed, owners may notice noise coming from the cover, damage to cover attachments, or cover movement against the truck's bed rails. The tonneau cover's attachment system may not sufficiently secure the tonneau cover to the truck bed rails if the attachment system is damaged or improperly installed, or if the recall repair in equipment recall 19E031 (N192217500) was improperly performed. If the tonneau cover detaches from a moving vehicle and falls into a roadway, it may increase the risk of a crash.

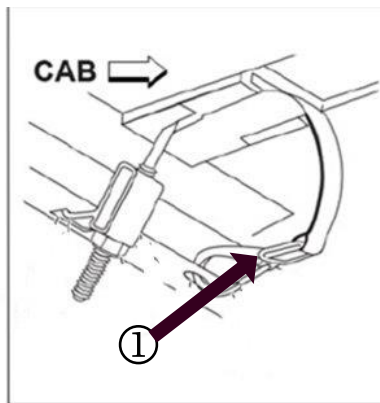
5613815

Open the front section of the tonneau cover and locate the outboard ends of the front hinge track. If the cover already has tethers (1) installed, it is up to date and no further action is required.

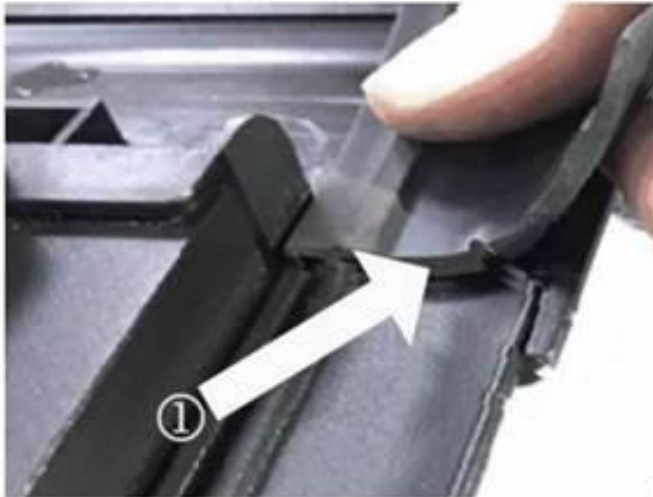
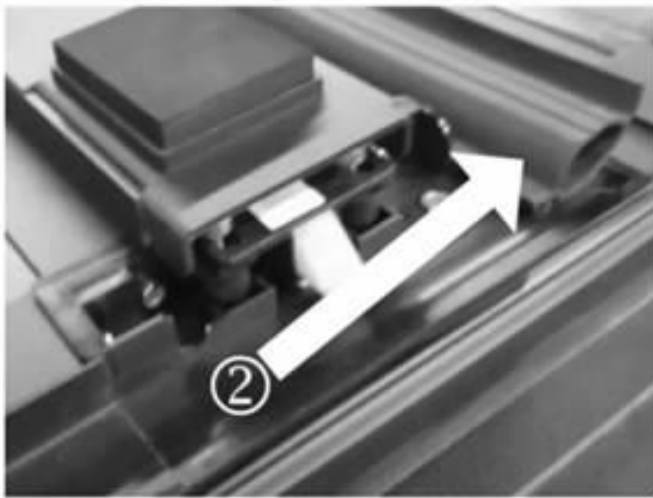
**Important:** Verify the front tonneau cover seal is the revised “fin” style seal (1). If the “bulb” style seal is installed (2), replace the seal. Refer to steps 1-5 of the Adjustment Instructions for Vehicles That Have NOT Had Recall N192217500 performed below.
