# Product Safety Recall

## N192285070 Tonneau Cover Retention

**Release Date:** September 2020

**Revision:** 01

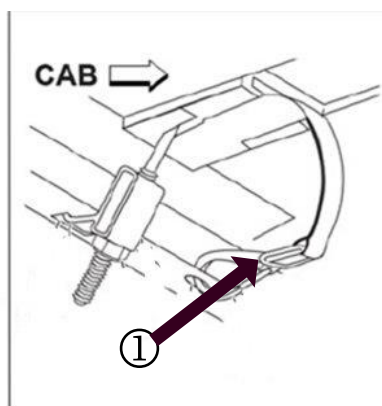
5613815

Open the front section of the tonneau cover and locate the outboard ends of the front hinge track. If the cover already has tethers (1) installed, it is up to date and no further action is required.
