# Product Safety Recall

## N192285070 Tonneau Cover Retention

**Release Date:** November 2020

**Revision:** 02

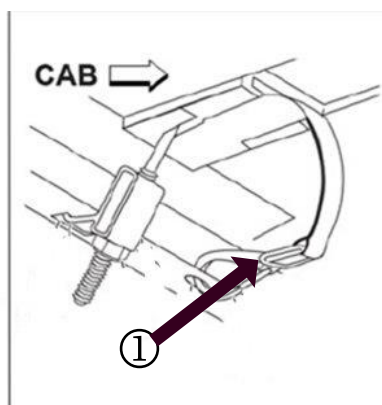
5613815

Open the front section of the tonneau cover and locate the outboard ends of the front hinge track. If the cover already has tethers (1) installed, it is up to date and no further action is required.
