N192290990 Front Passenger Air Bag Inflator – US Only

Release Date: January 2020 Revision: 01

Condition	TK Global LLC ("Takata") has decided that a defect which relates to motor vehicle safety exists in certain
	2007-2008 model year Chevrolet Silverado and GMC Sierra 2500/3500 series heavy duty pickup trucks.
	Takata has determined that some of the front passenger air bag inflators in these vehicles may
	experience an alteration over time, which could lead to overaggressive combustion in the event of an air
	bag deployment. This condition could create excessive internal pressure when the air bag is deployed,
	which could result in the body of the inflator rupturing upon deployment. In the event of an inflator rupture,
	metal fragments could pass through the air bag cushion material, which may result in injury or death to
	vehicle occupants.
Correction	Dealers will replace the front passenger air bag inflator module.

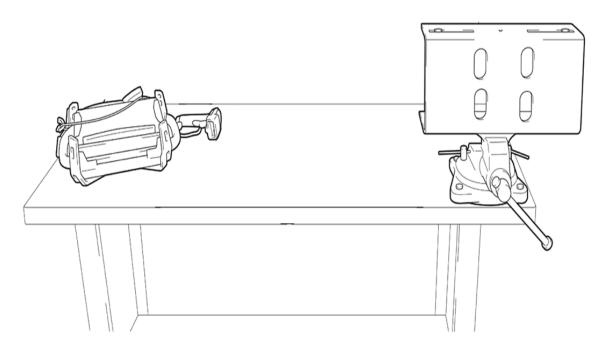
3607819

Danger: To avoid personal injury or death, it is critical to use an air bag module bracket when replacing an inflator module. Carefully read and follow the instructions below:

- 1. Confirm the bracket assembly is installed securely in the vice.
- 2. Confirm there are no loose objects or people exposed to the back side of the bracket for safety in the unlikely event of air bag deployment due to improper work procedures. The air bag is NOT being replaced due to an inadvertent deployment concern.
- 3. Confirm that no objects, tools or people are within 3 feet (1 meter) of the back side of the bracket.
- 4. Confirm that no objects, tools or people are within 2 feet (0.6 meters) of the sides of the bracket.
- 5. BEFORE starting work and periodically while working on the air bag module, touch a metallic part of the work bench to discharge static electricity in the body.
