# Product Safety Recall

## N192278940 Incorrect Passenger Airbag

**Release Date:** February 2020

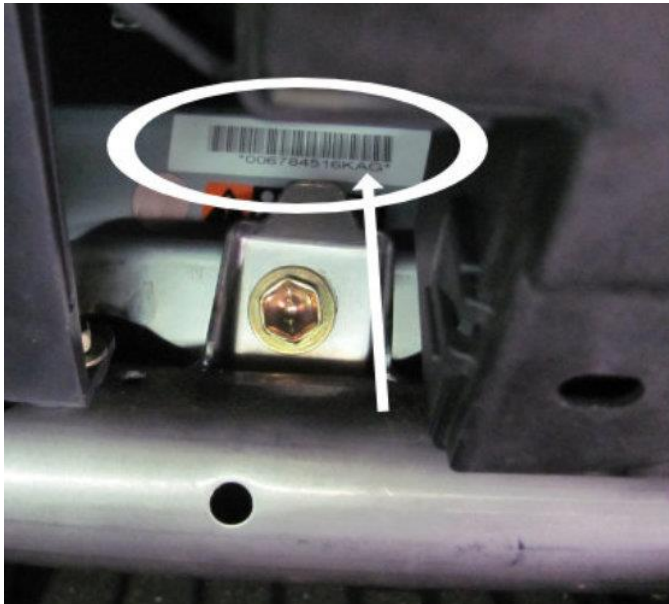
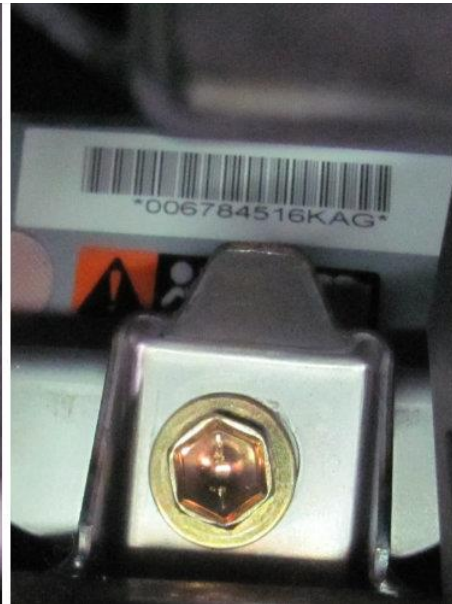
5494479

<b>Condition</b>	General Motors has decided that a defect which relates to motor vehicle safety exists in certain 2003-2004 model-year Pontiac Vibe vehicles. These vehicles may have received a replacement front-passenger airbag module that is the subject of Toyota recall 19V-627, which covered certain 2005-2008 model year Pontiac Vibe vehicles. Toyota’s Part 573 report for 19V-627 states, in part:  “There is a possibility that the air bag may not unfold as designed during inflation under high temperature conditions, resulting in air bag internal pressure rising differently than expected. Under such conditions, a portion of the air bag material could be torn during deployment, or the bag plate (which mounts the air bag to the air bag assembly case) could be damaged. In either instance, such damage during deployment could cause the air bag not to properly inflate, and this could increase the risk of occupant injury in the event of a crash.”

Picture above shows incorrect airbag module barcode "AG".

2. Inspect the barcode on the airbag module:
  - If the barcode ends in "AG", replace the instrument panel passenger air bag module. Continue to step 3.
  - If the barcode ends in "AF", no further action is required. Install the instrument panel (I/P) compartment. Refer to *Instrument Panel Compartment Replacement in Instrument Panel, Gauges and Console* in SI.
3. Connect the scan tool and determine if any diagnostic trouble codes (DTCs) have been set. Record set DTCs, if present, on the job card.
4. Remove the instrument panel (I/P) compartment. Refer to *Instrument Panel Compartment Replacement* in SI.
5. Disconnect cable from negative battery terminal. Refer to *Battery Negative Cable Disconnection and Connection* in SI.

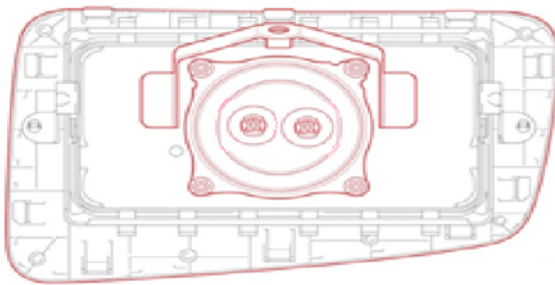
4486640

**Warning:** The air bag and air bag harness for 2003-2004 and 2005-2008 vehicles are identical in appearance and installation. The two air bag designs, however, are NOT interchangeable and have different performance characteristics. Installing an incorrect air bag module may reduce occupant protection in the event of a crash and increase the risk of personal injury. Ensure the correct air bag is installed into the vehicle by verifying the air bag part number and air bag bar code number BEFORE installing the air bag.

4. Install the new module.
  - 4.1. Carefully slide the new module into the airbag door. Note the mounting direction.
