# Product Safety Recall

## N192278940 Incorrect Passenger Airbag

Release Date: January 2020

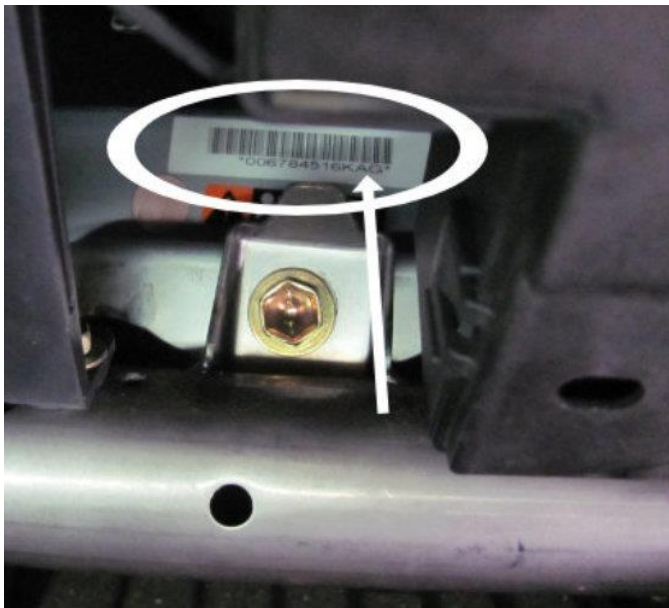
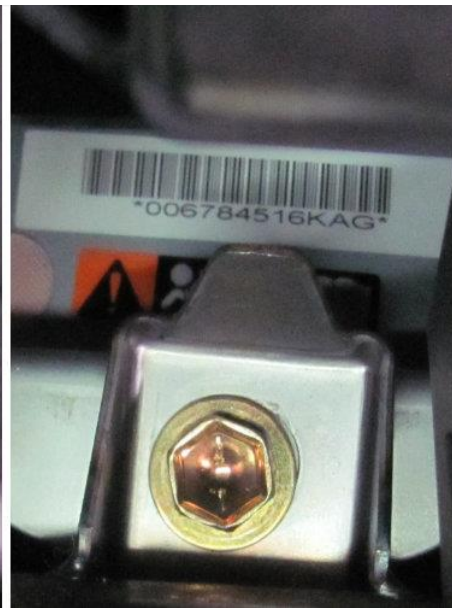
5494479

Picture above shows incorrect airbag module barcode "AG".

2. Inspect the barcode on the airbag module:
  - If the barcode ends in "AG", replace the instrument panel passenger air bag module. Continue to step 3.
  - If the barcode ends in "AF", no further action is required. Install the instrument panel (I/P) compartment. Refer to *Instrument Panel Compartment Replacement in Instrument Panel, Gauges and Console* in SI.
3. Connect the scan tool and determine if any diagnostic trouble codes (DTCs) have been set. Record set DTCs, if present, on the job card.
4. Remove the instrument panel (I/P) compartment. Refer to *Instrument Panel Compartment Replacement* in SI.
5. Disconnect cable from negative battery terminal. Refer to *Battery Negative Cable Disconnection and Connection* in SI.

<b>Correction</b>	Dealers will inspect the passenger air bag module and replace if necessary.
