SAFETY RECALL NOTICE

McLaren Voluntary Safety Recall Removal of Engine Floor Panel NVH Foam Padding (and Potential Fuel Tank Replacement)

Bulletin type:	Safety Recall Campaign
Reference number:	AFT.027.2020
Affected vehicles:	McLaren 570GT, McLaren GT, McLaren 720S (Coupe and Spider), McLaren Senna
Attention:	All Retailer Staff
Situation:	Voluntary Safety Recall - Potential for corrosion of the fuel tank
Procedure:	Action affected vehicles on next Retailer visit. Please refer to the information outlined in this document to remove the NVH foam padding on the engine floor panel and inspect the fuel tank for possible corrosion
Date:	2 nd July 2020

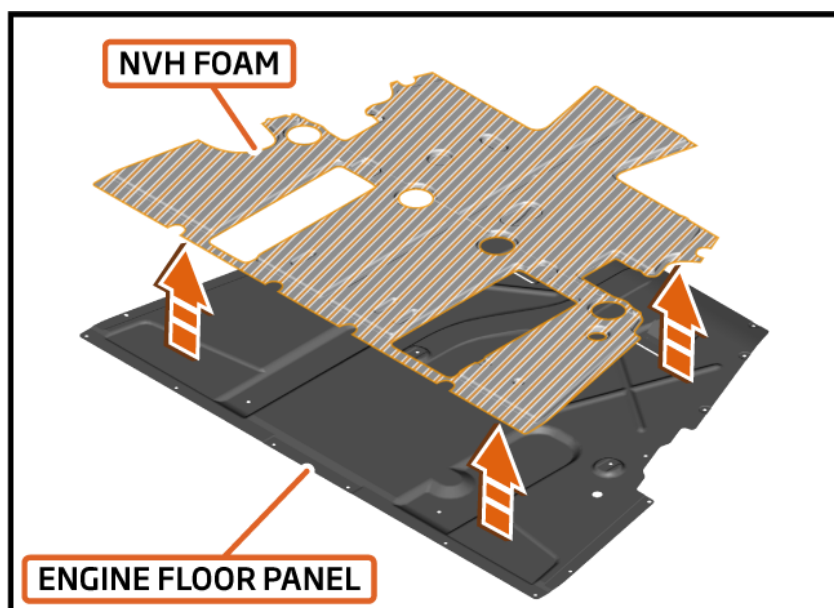
4.1 Procedure

This voluntary recall relates to the fact that the Noise, Vibration and Harshness (NVH) foam padding positioned on the underside of the fuel tank can, in some instances, trap corrosive moisture, which can over time cause corrosion of the fuel tank. If not addressed, the corrosion may cause fuel vapour or liquid fuel to leak from the fuel tank, which could increase the risk of a fire.

1. Remove the engine floor panel
2. Inspect the fuel tank for signs of corrosion and / or leakage
 - a. If no signs of corrosion and / or leakage are found, continue to step 3
 - b. If signs of corrosion and / or leakage are found, please submit a Technical Request - Refer to section 4.2 below
3. Remove all the NVH foam padding on the engine floor panel
4. Clean off the residual adhesive which is left on the engine floor panel
5. Re-install the engine floor panel

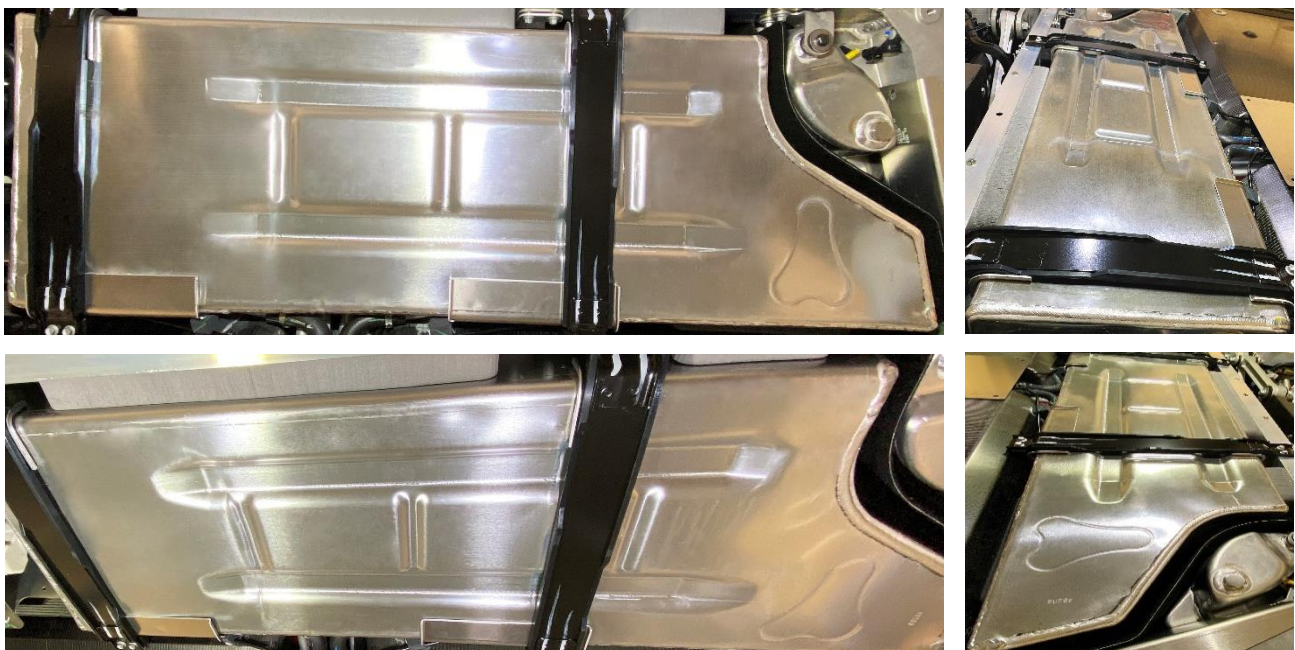
If signs of corrosion and / or leakage are found, raise a TR and attach pictures of the fuel tank to show the overall condition (from angles similar to the below example pictures) and also additional pictures focusing on any signs of localised corrosion and / or pitting.

If signs of localised corrosion and / or pitting is evident, carry out the following steps where possible and provide the recorded values when submitting the TR:

- Carefully remove any oxidised material and note the amount of excess removed
- Measure the diameter of the concerned area(s) using a suitable tool i.e. vernier gauge
- Measure the depth of the concerned area(s) using a suitable tool i.e. depth gauge
