F/CMVSS Noncompliance Recall

N202309350 Interior Trunk Release Button Inoperative Ten Minutes After Power Off

Release Date: September 2020

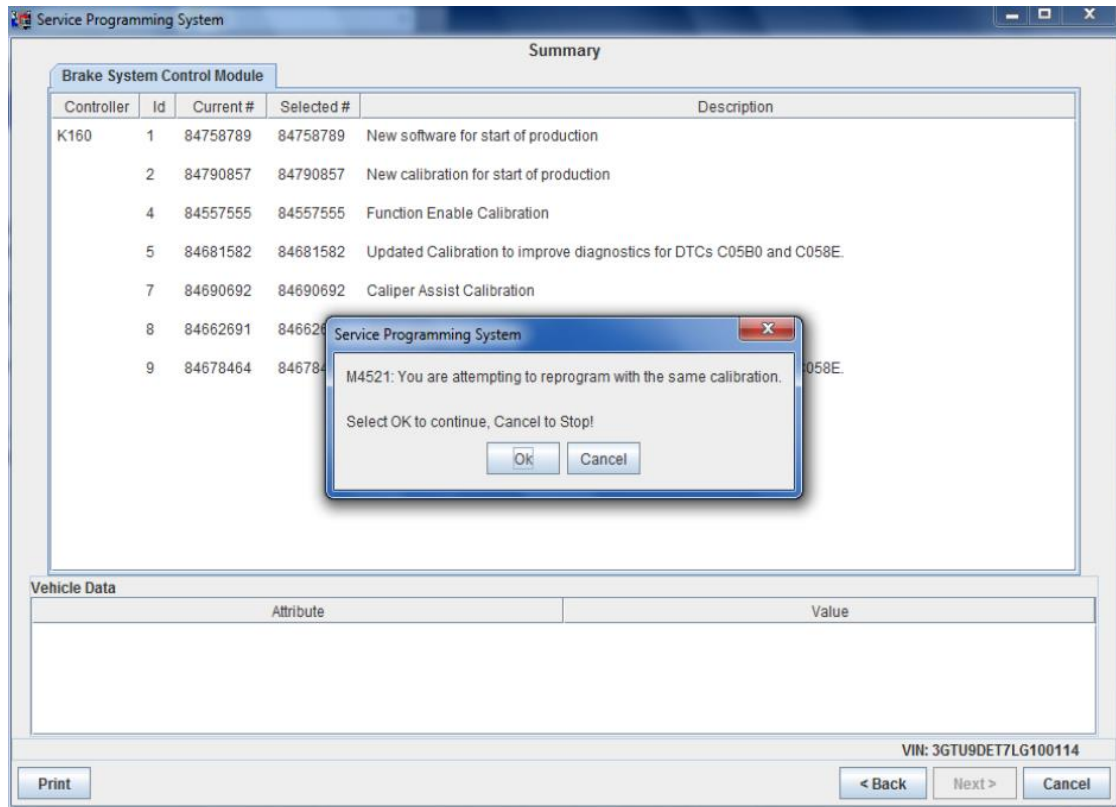
5431207

Important: TIS2WEB and Techline Connect screens shown above.

Important: If the Same Calibration/Software Warning is noted on the TLC or SPS Summary screen, select OK and follow screen instructions. After a successful programming event, the WCC is located in the Service Programming System dialogue box of the SPS Summary screen. No further action is required. Refer to the Warranty section of the bulletin.

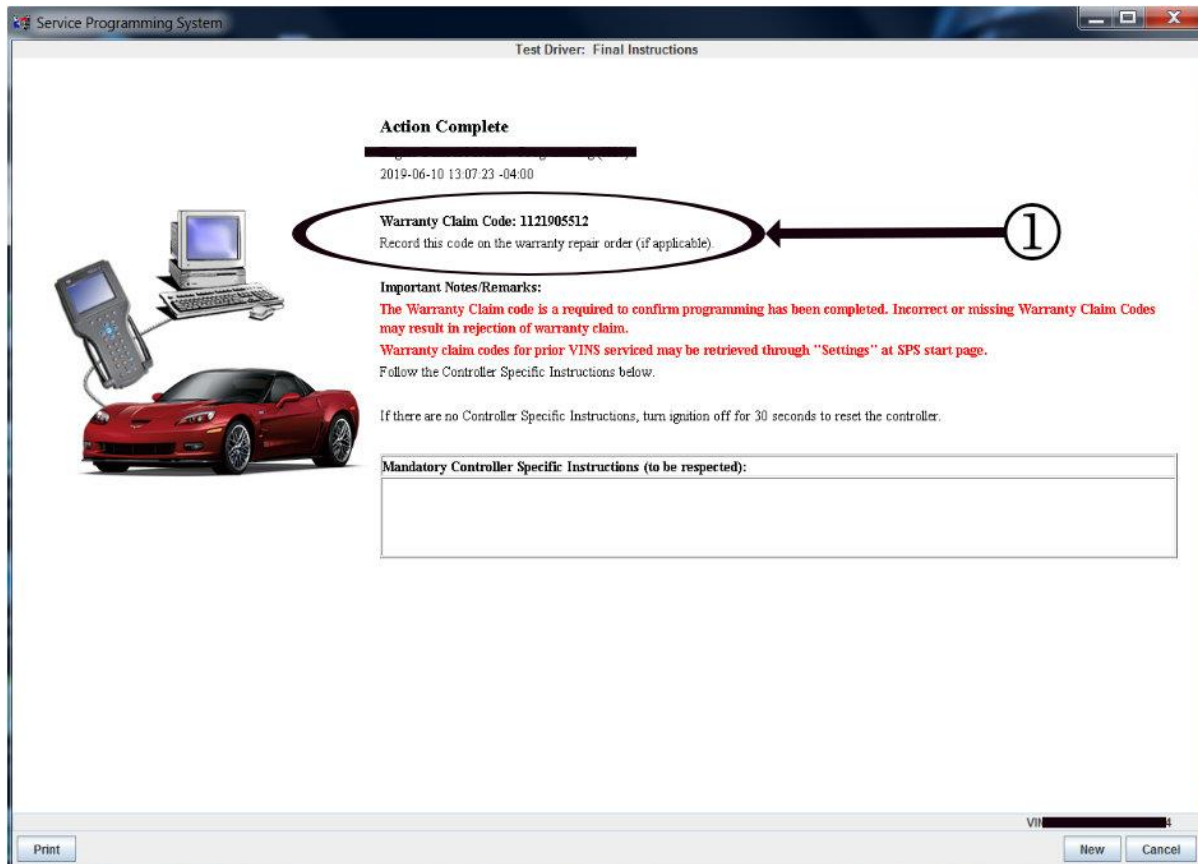
5431209

Important: To avoid warranty transaction rejections, you **MUST** record the warranty claim code provided on the Warranty Claim Code (WCC) screen shown above on the job card. Refer to callout 1 above for the location of the WCC on the screen.

- Record SPS Warranty Claim Code on job card for warranty transaction submission.
- After the BCM (body control module) has been updated, drive the vehicle to relearn the tire pressure monitor sensors. If the vehicle is not driven, the IPC will show "dashes" instead of the actual tire pressure.
- Inform the customer that the key FOB operation has been updated. To open the hood using the key FOB, press and release the button followed by pressing and holding to open.
