Product Safety Recall

N202306620 Loss of Power Steering Assist

Release Date: August 2020

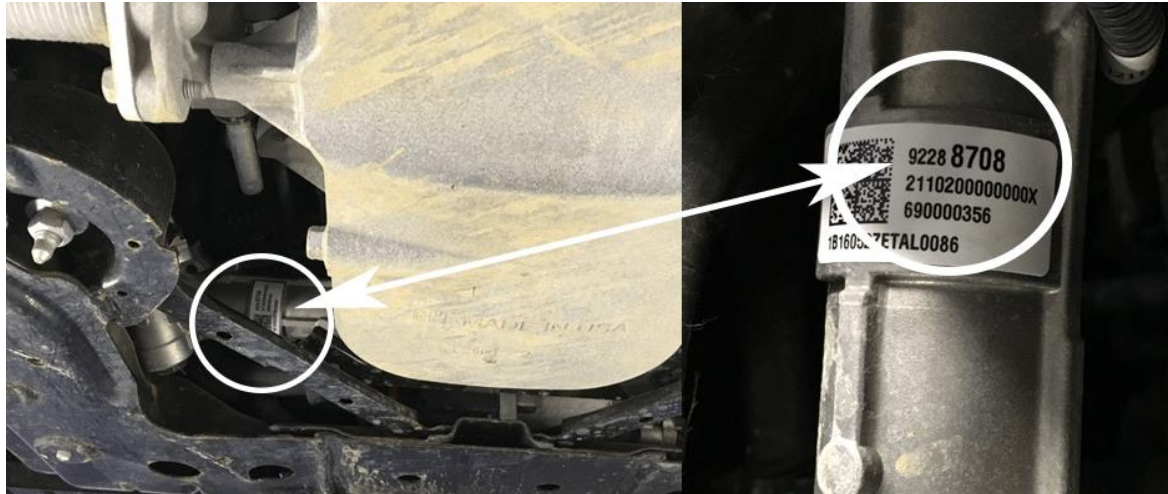
4780576

Condition	General Motors has decided that a defect which relates to motor vehicle safety may exist in certain 2014-2016 model year Chevrolet Caprice police pursuit vehicles. GM's warranty records indicate that the inspection procedure in NHTSA recall 17V265 may have been performed incorrectly on these vehicles. NHTSA recall 17V265 intended to address the potential for fretting corrosion to occur in the terminals that connect the electronic power steering (EPS) module and the torque sensor. Corrosion on these terminals could potentially lead to a loss of EPS. Because the inspection procedure may have been performed incorrectly, these vehicles may still be equipped with a recalled steering-gear assembly. If power steering is lost, manual steering functionality is retained but would require an increased steering effort, particularly at lower speeds, increasing the risk of a crash.
Correction	Dealers will inspect the steering gear assembly part number and, if it is not an approved part number, replace it.

1. Raise the vehicle and remove the front bumper fascia extension. Refer to *Front Bumper Fascia Extension Replacement* in SI.
2. Inspect the part number on the electric belt drive rack and pinion steering gear:
 - If the vehicle steering gear part number IS NOT 92289255, 92289251, or 92288914 replace the steering gear assembly. Proceed to step 3.
 - If the vehicle has steering gear part number 92289255, 92289251, or 92288914 already installed, record the part number of the currently installed gear in your warranty claim. Reinstall the front bumper fascia extension. Refer to *Front Bumper Fascia Extension Replacement* in SI.
3. Remove the Electric Belt Drive Rack and Pinion Steering Gear. Refer to *Electric Belt Drive Rack and Pinion Steering Gear Replacement* in SI.
