Product Safety Recall

N202300860 Loss of Brake Assist

Release Date: October 2020

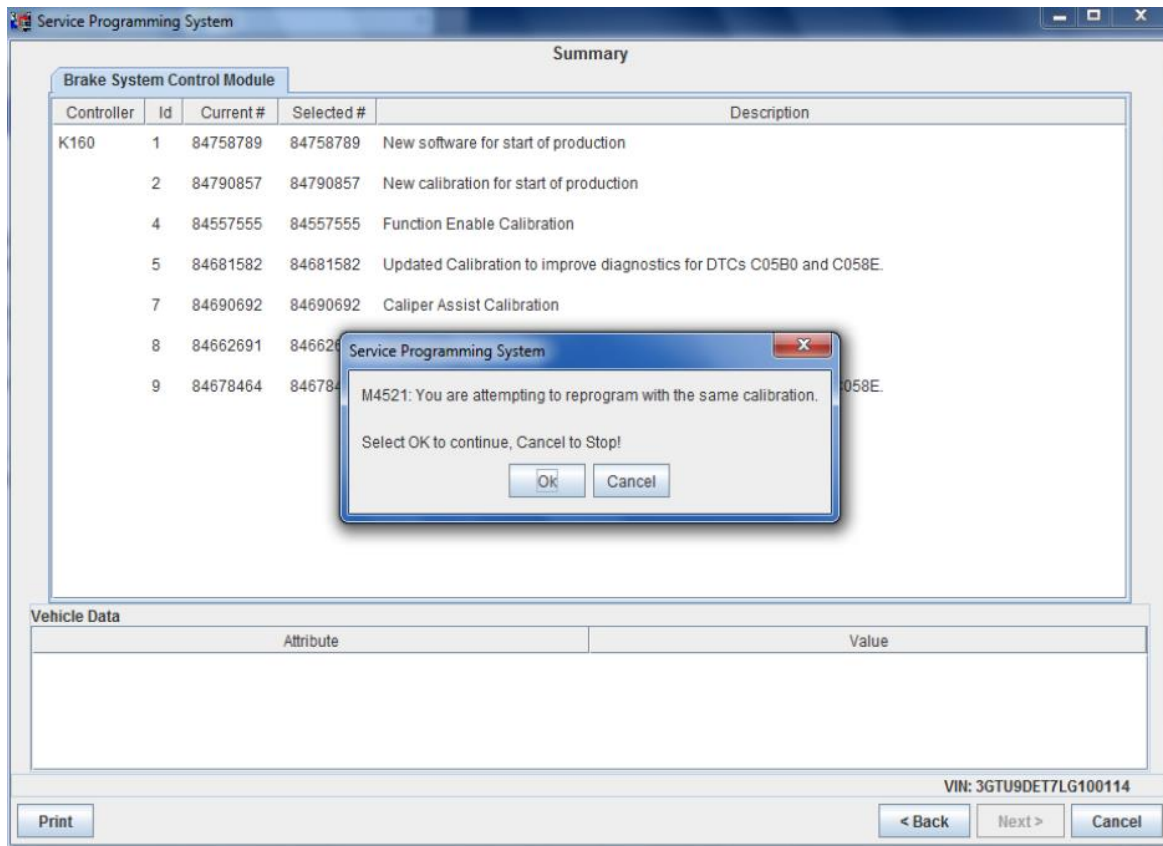
5431207

Important: Techline Connect and TIS2WEB screens shown above.

Important: If the same calibration/software warning is noted on the TLC or SPS Summary screen, select OK and follow screen instructions. After a successful programming event, the WCC is located in the Service Programming System dialogue box of the SPS Summary screen. No further action is required. Refer to the Warranty section of the bulletin.
