WARRANTY BULLETIN SAFETY CAMPAIGN

Campaign no.: 2020-0008

Subject: **Possible Front Wheel Loss**

No. **2020-6**

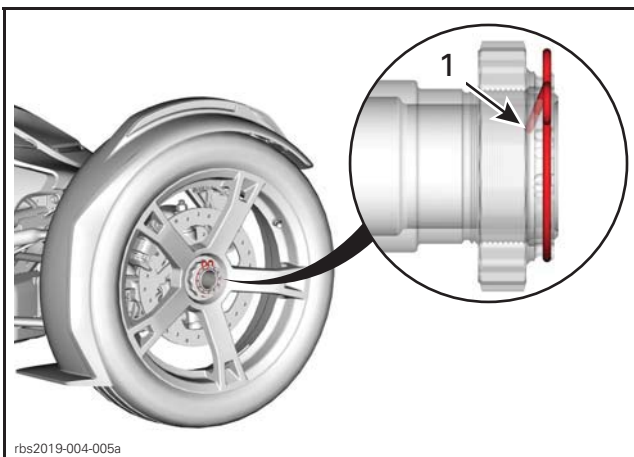
rbs2019-004-005a

A properly installed red locking clip is sitting well into the groove all around the nut.

1. Folded end pointing inside the drive axle

1. Reinstall the red locking clip.
2. RED locking clip installation is **Mandatory**
The folded end must point inside the drive axle.
