Recall Information Bulletin

No: C10118 **Issued:** 6/14/2021

Re: Vacuum Pump

Safety Recall C10118 – Vacuum Pump

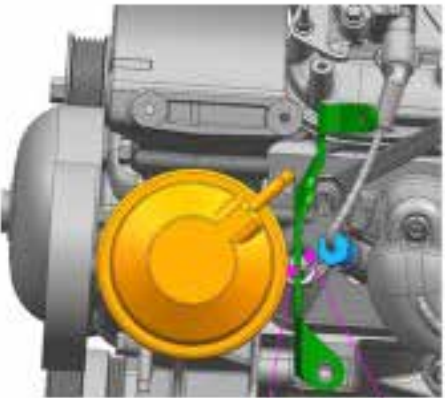
Clearance check on DMU=> 5mm

GOOD (about 5 mm clearance), tighten M8 with the bracket flush against the engine A/C boss

NO GOOD (insufficient clearance), when M10 is tightened first

Too narrow (less than 5mm)
