Product Safety Recall

N202311731 High Voltage Battery May Melt or Burn

Release Date: May 2021

Revision: 01

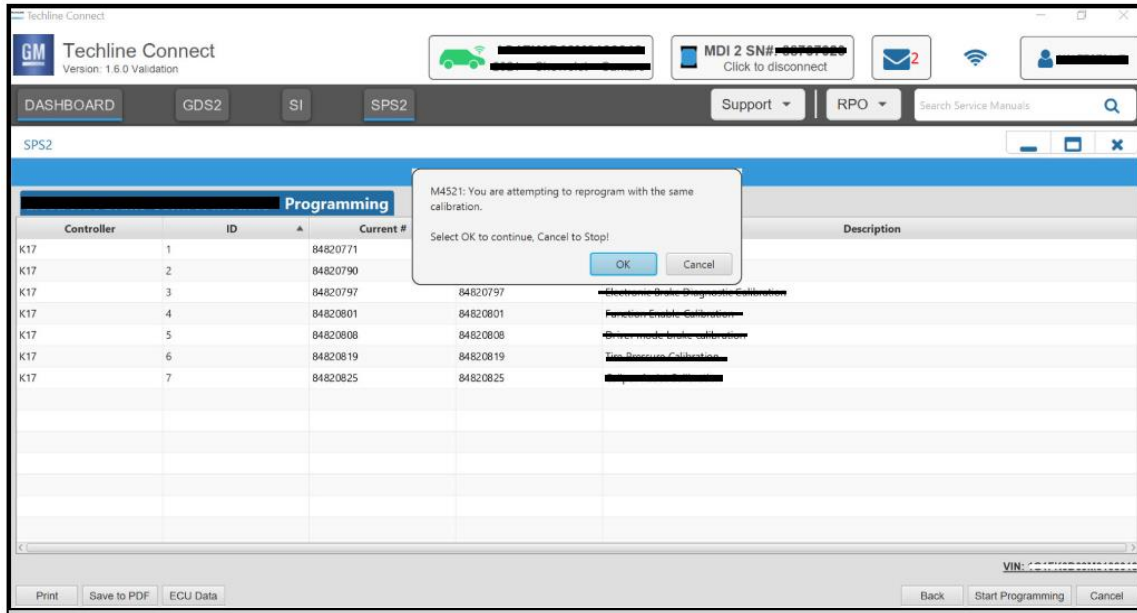
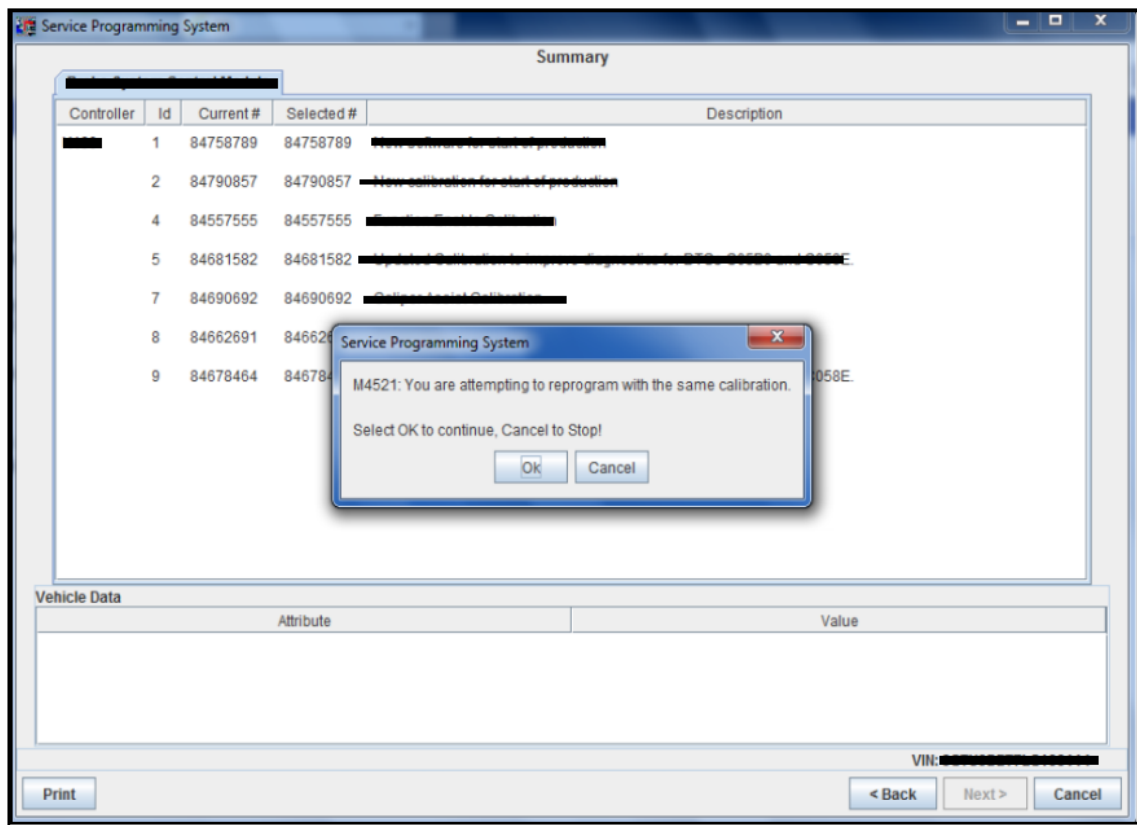
Important: Techline Connect and TIS2WEB screens shown above.

Important: If the same calibration/software warning is noted on the TLC or SPS Summary screen, select OK and follow screen instructions. After a successful programming event, the WCC is located in the Service Programming System dialogue box of the SPS Summary screen. No further action is required. Refer to the Warranty section of the bulletin.

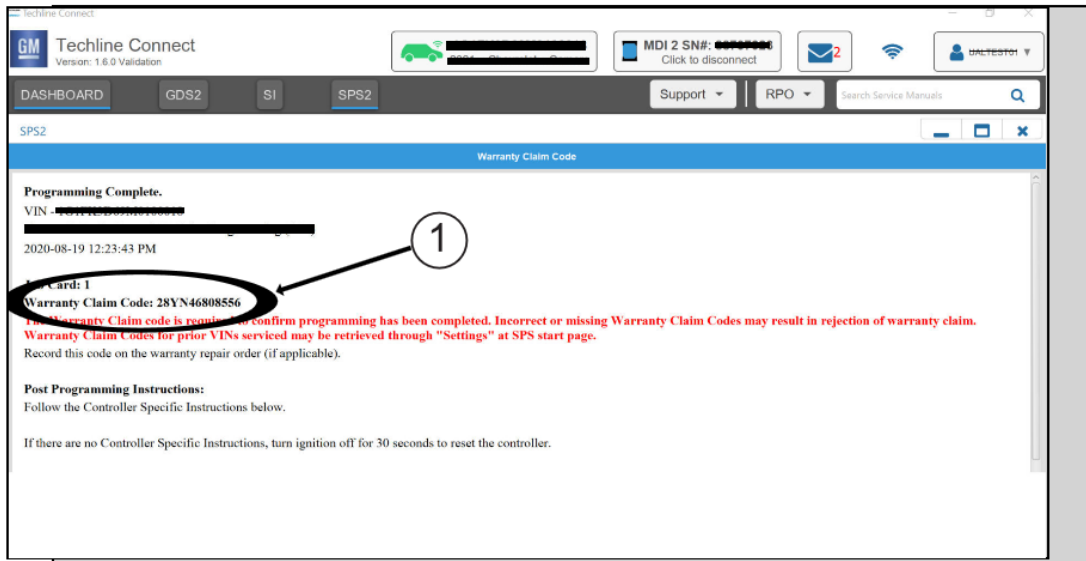
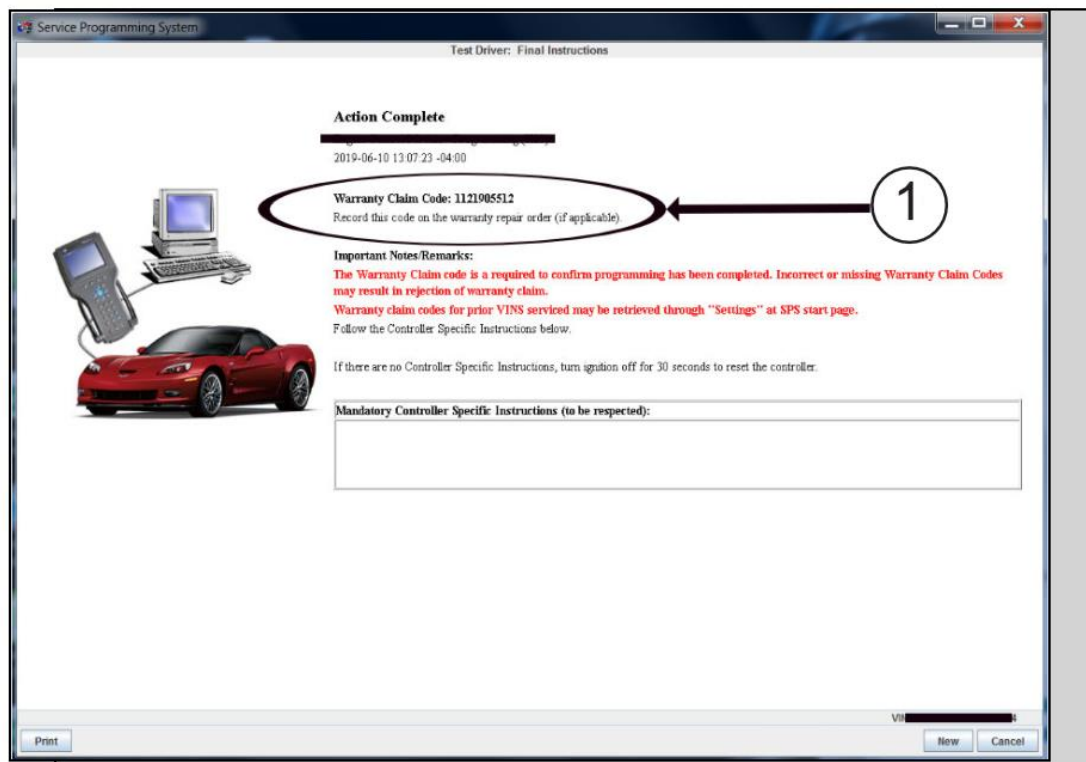
Note: The screenshots above are an example of module programming and may not be indicative of the specific module that is being programmed. Module selection and VIN information have been blacked out.

Important: To avoid warranty transaction rejections, you **MUST** record the warranty claim code provided on the Warranty Claim Code (WCC) screen shown above on the job card. Refer to callout 1 above for the location of the WCC on the screen.

3. Record SPS Warranty Claim Code on job card for warranty transaction submission.
