Product Safety Recall

N202311731 High Voltage Battery May Melt or Burn

Release Date: July 2021

Revision: 02

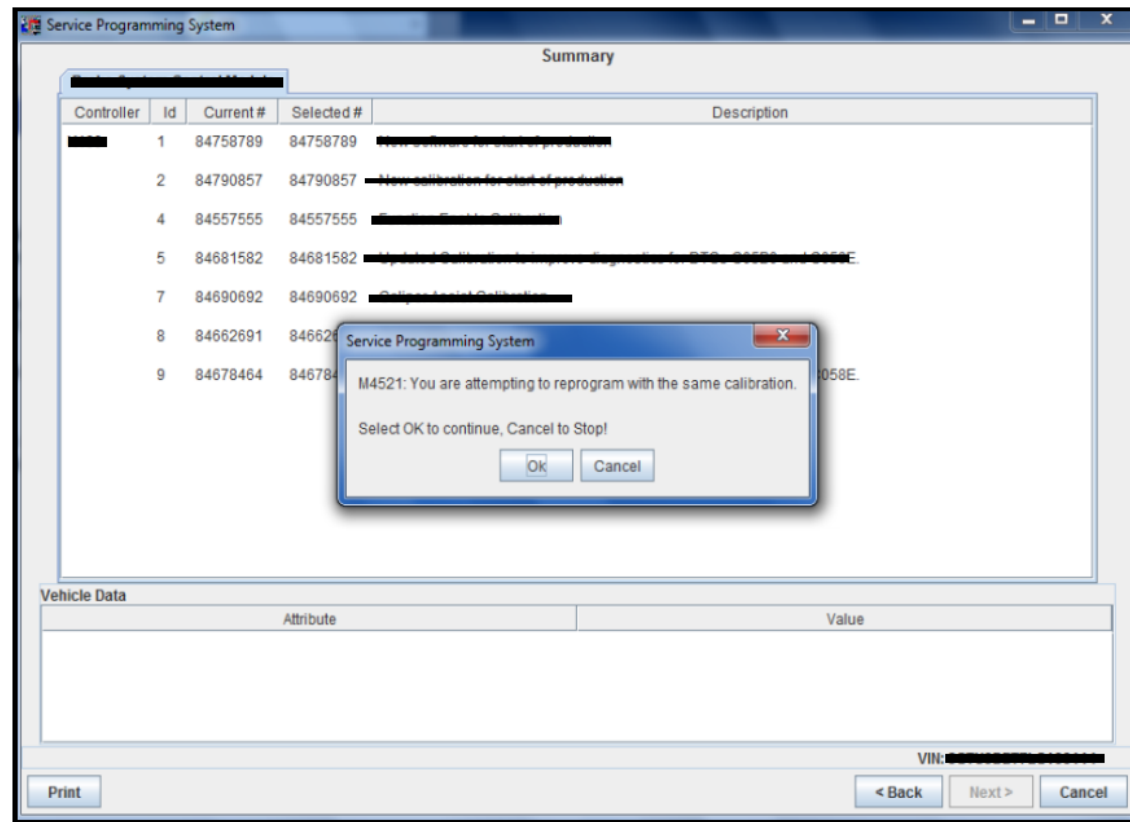
5431207

Important: Techline Connect and TIS2WEB screens shown above.

1. Reprogram the K114B Hybrid/EV Powertrain Control Module 2. Refer to *K114B Hybrid/EV Powertrain Control Module 2: Programming and Setup* in SI.
2. Reprogram the K9 Body Control Module. Refer to *K9 Body Control Module Programming and Setup* in SI.

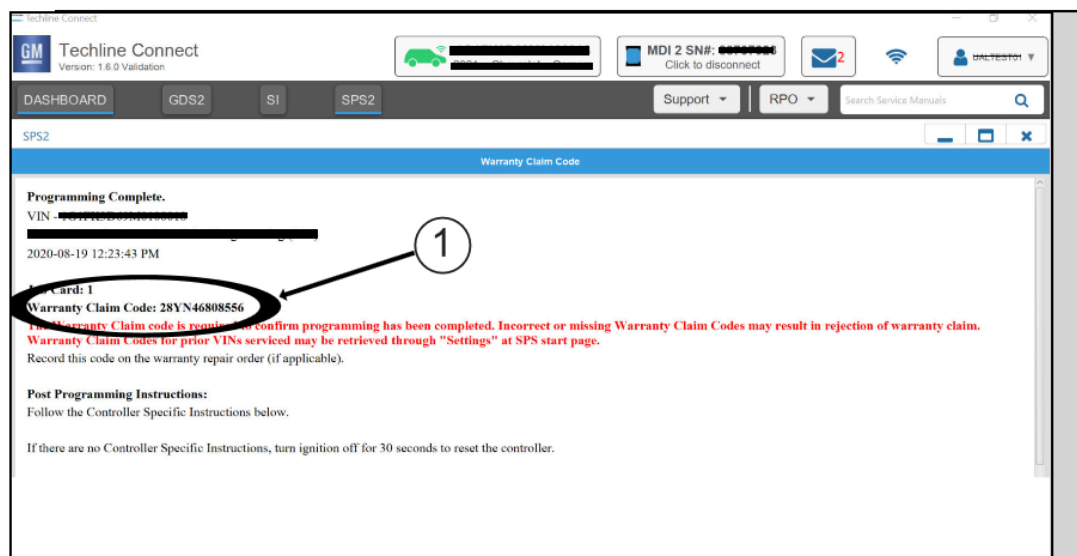
5644478

Note: The screenshots above are an example of module programming and may not be indicative of the specific module that is being programmed. Module selection and VIN information have been blacked out.

Important: To avoid warranty transaction rejections, you **MUST** record the warranty claim code provided on the Warranty Claim Code (WCC) screen shown above on the job card. Refer to callout 1 above for the location of the WCC on the screen.
