F/CMVSS Noncompliance Recall

N202319980 Safety Telltale Light Daytime Visibility

Release Date: December 2020

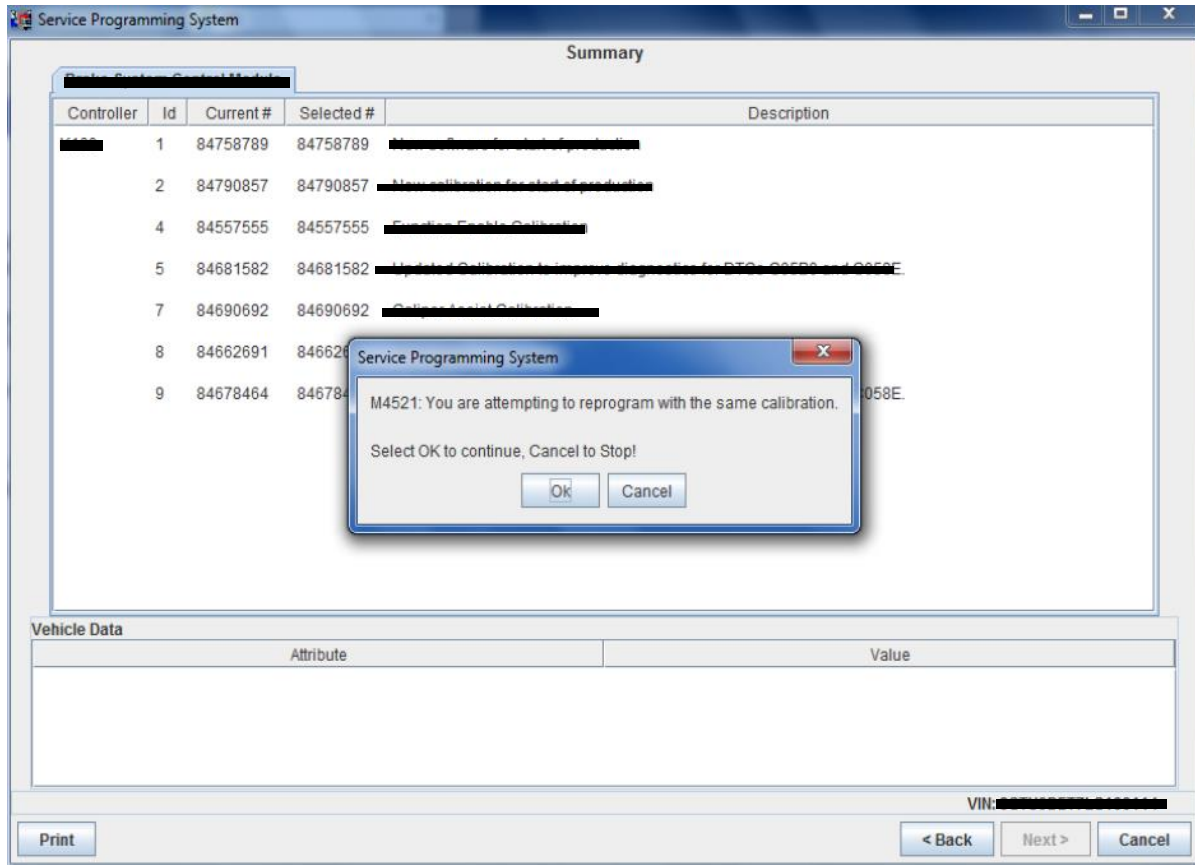
5431207

Important: Techline Connect and TIS2WEB screens shown above.

Important: If the same calibration/software warning is noted on the TLC or SPS Summary screen, select OK and follow screen instructions. After a successful programming event, the WCC is located in the Service Programming System dialogue box of the SPS Summary screen. No further action is required. Refer to the Warranty section of the bulletin.

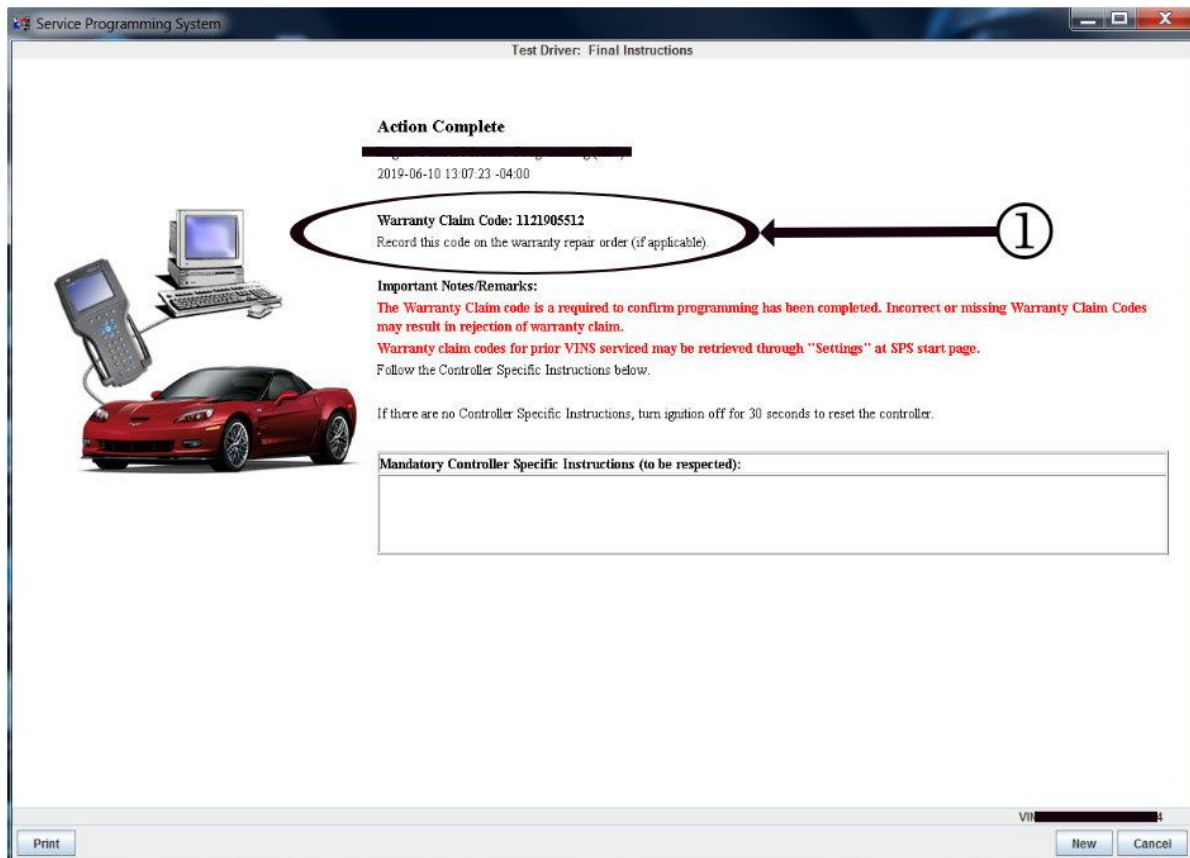
5431209

Important: To avoid warranty transaction rejections, you **MUST** record the warranty claim code provided on the Warranty Claim Code (WCC) screen shown above on the job card. Refer to callout 1 above for the location of the WCC on the screen.

2. Record SPS Warranty Claim Code on job card for warranty transaction submission.
