Product Safety Recall

N202314670 Front Center Seat Belt May Not Be Attached

Release Date: December 2020

Revision: 01

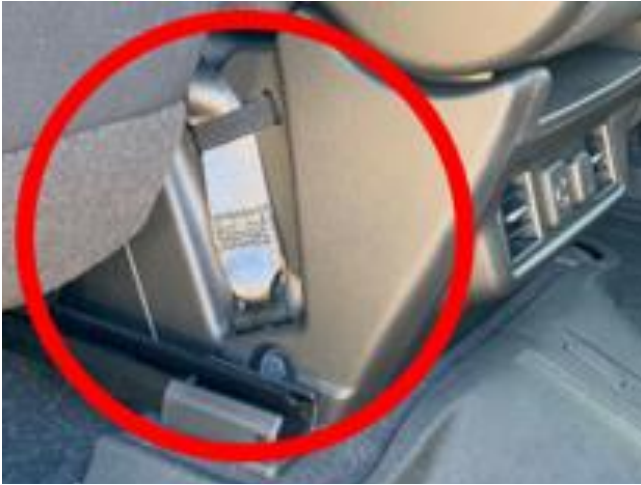
5695741

1. Move the left and right front seats to the full forward position. Position the seat backs in the full upright position.

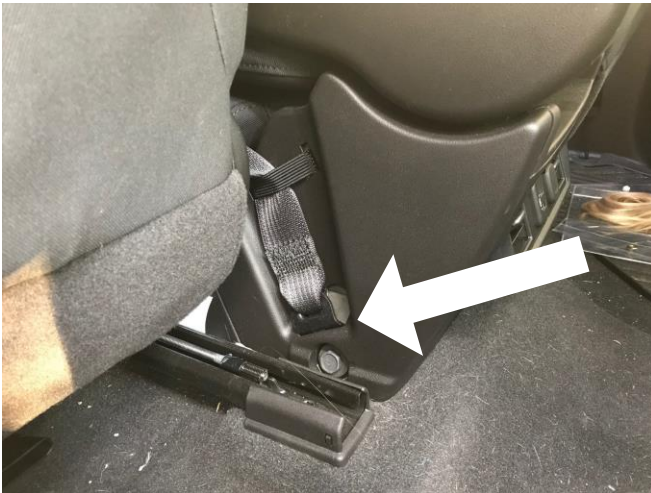
5695743

2. Access the left and right attachment locations for the center seat belt buckle and retractor belt.
3. Visually verify the left and right seat-belt attachment brackets are positioned in the seat base correctly and secured by the bolt.

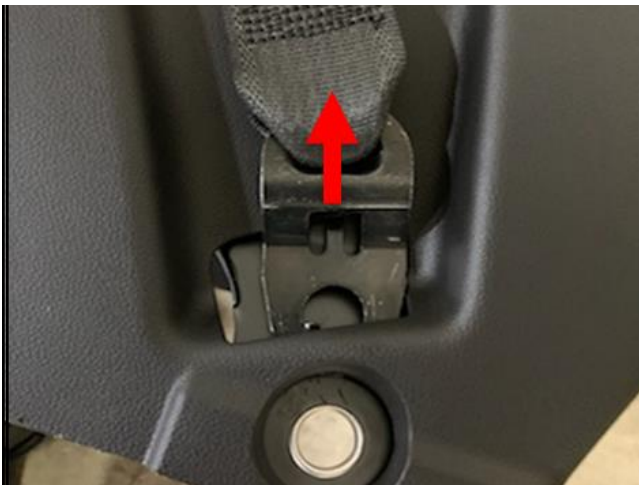
5695744

Seat-Belt Bracket Positioned Correctly, Securing Bolt Through Hole in Belt Bracket.

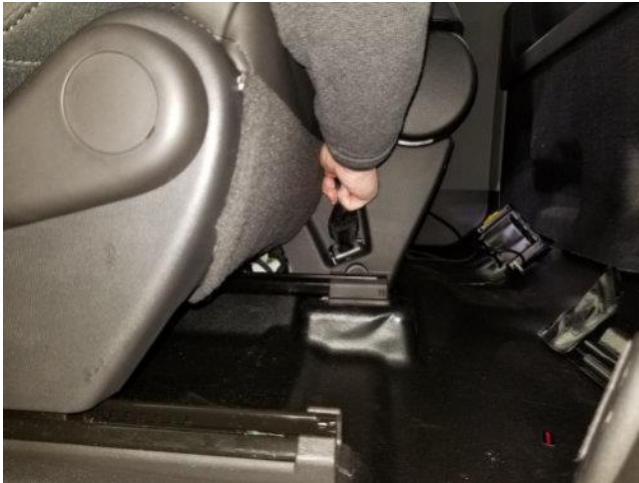
5695745

Seat-Belt Bracket Positioned Too High, Securing Bolt Not Through Hole in Bracket.

4. Further verify the seat belt attachments by firmly pulling outward (toward the door opening) on the belt in the area between the elastic band and the mounting bolt. Look for any movement of the seat-belt bracket at the seat base. Repeat this action three times.
5. **If both seat belts are attached correctly**, no further action is required.
6. **If a seat belt is not secured correctly**, perform the following steps:
 - Remove the four seat mounting bolts. Refer to *Front Seat Removal and Installation* in SI. DO NOT remove the seat assembly.
 - Carefully shift the seat assembly forward in the vehicle enough to allow access to the seat belt mounting bolt.
 - Remove the seat belt mounting bolt.
