# Product Safety Recall

## N202322234 Seat Belt May Not Be Properly Attached

Release Date: December 2020

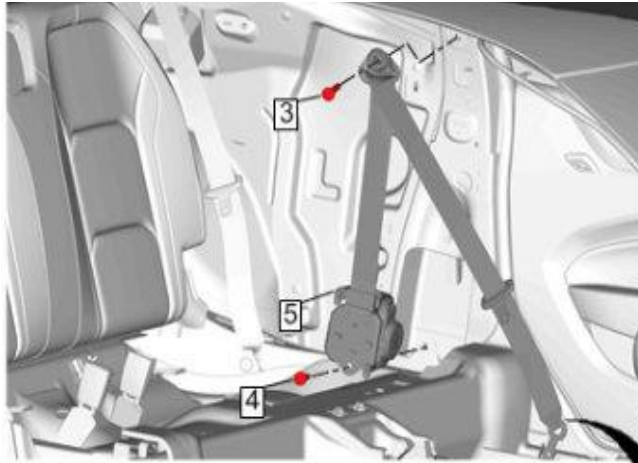
5699168

### Front Row Left and Right Seat Belt Retractor Mounting Bolt Replacement (Coupe Vehicles)

2. Remove the front seat belt retractor mounting bolt (4). Discard the bolt.
3. Install the new seat belt retractor mounting bolt (4). Refer to the note above for installation details. Tighten the new service bolt to 45 N.m (33 lb. ft).
4. Reinstall the left quarter lower rear trim panel. Refer to *Quarter Lower Rear Trim Panel Replacement* in SI. If the rear seat belt anchor mounting bolt requires replacement, perform that procedure before reinstalling the trim panel.
5. Repeat steps 1-4 on the right-side seat belt retractor mounting location.

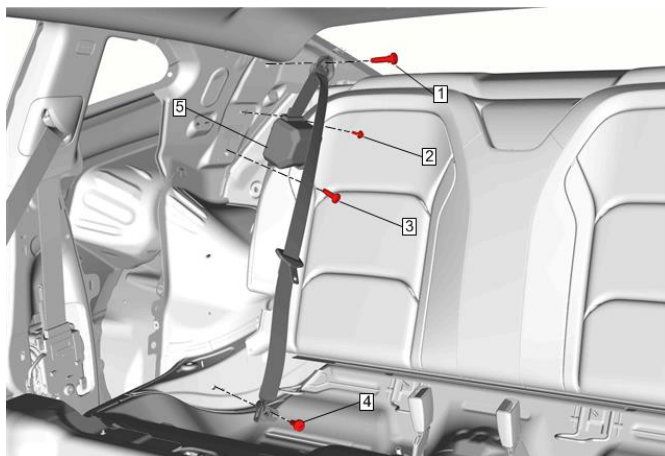
4140498

### Rear Seat Belt Anchor Mounting Bolt Replacement (Coupe Vehicles)

1. Remove and discard the seat belt anchor bolt (4).
2. Install the new seat belt anchor mounting bolt (4). Refer to the note above for installation details. Tighten the new service bolt to 45 N.m (33 lb. ft).
3. Reinstall the quarter lower rear trim panel. Refer to *Quarter Lower Rear Trim Panel Replacement* in SI.

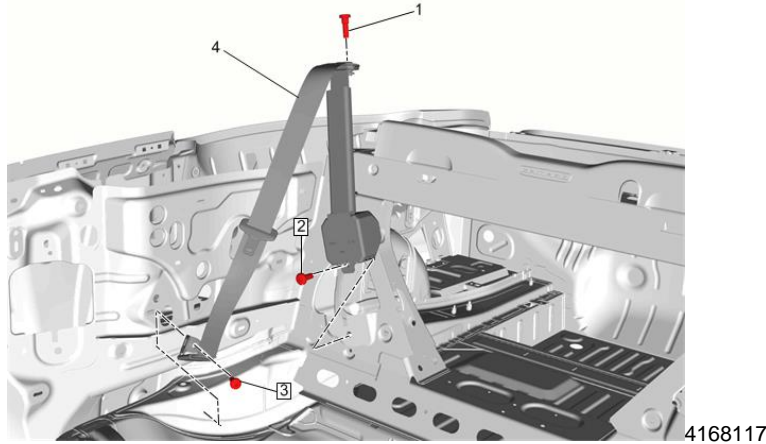
### Rear Seat Belt Anchor Mounting Bolt Replacement (Convertible Vehicles)

2. Remove and discard the seat belt anchor bolt (3).
3. Install the new seat belt anchor mounting bolt (3). Refer to the note above for installation details. Tighten the new service bolt to 45 N.m (33 lb. ft).
4. Reinstall the quarter lower rear trim panel. Refer to *Lower Rear Trim Panel Replacement* in SI.
