Product Safety Recall

N202322231 Seat Belt May Not Be Properly Attached

Release Date: December 2020

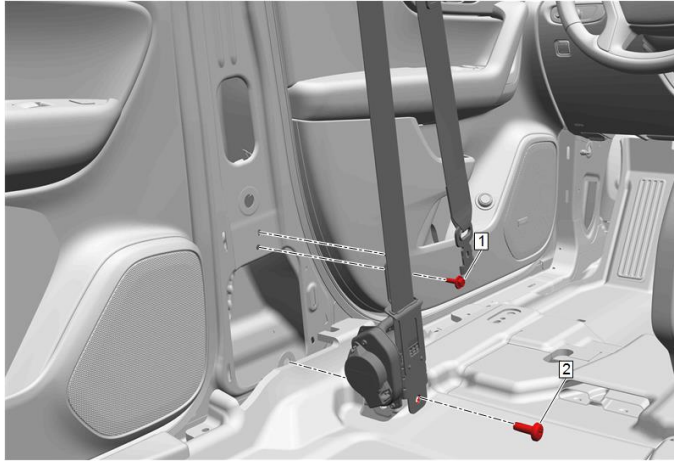
5148395

NOTE: Driver side shown. Passenger side similar.

2. Remove and discard the lower retractor bolt (2).
3. Install the new retractor mounting bolt. Refer to the note above for installation details. Tighten the new service bolt to 45 N.m (33 lb. ft).
4. Reinstall the center pillar lower trim panel. Refer to *Center Pillar Lower Trim Panel Replacement* in SI.

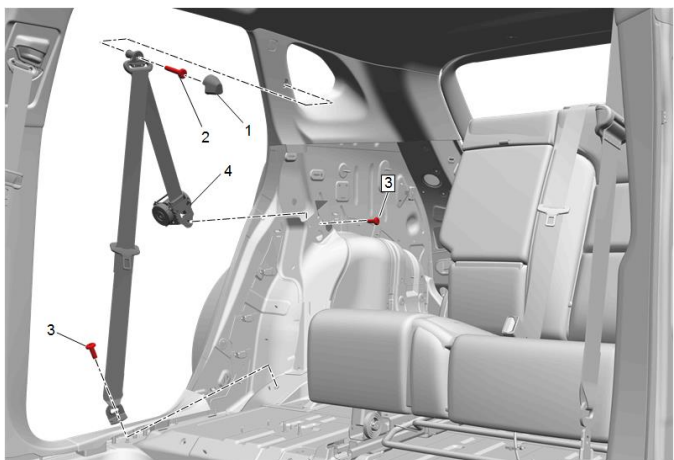
5142571

NOTE: Passenger side shown. Driver side similar.

2. Remove the second-row seat belt retractor bolt (3) and seat belt anchor bolts (3) Discard the bolts.
3. Install **TWO** new bolts, one at the seat belt retractor and the second at the seat belt anchor bracket. Refer to the note above for installation details. Tighten the new service bolts to 45 N.m (33 lb. ft).

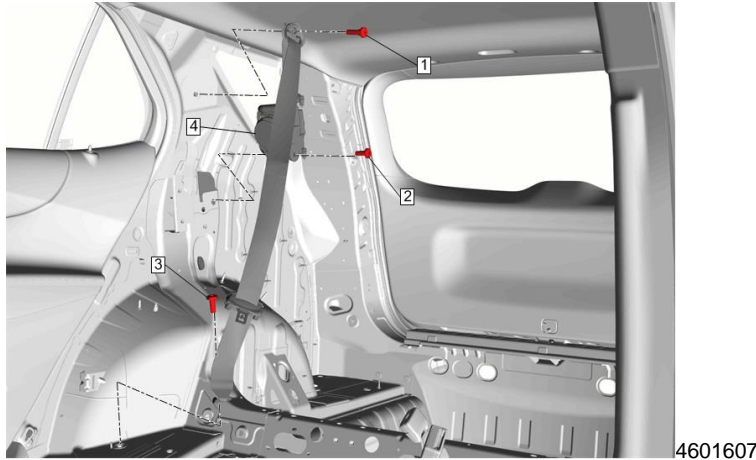
NOTE: Passenger side shown. Driver side similar.

2. Remove the second-row seat belt retractor bolt (2) and seat belt anchor bolts (3) Discard the bolts.
3. Install **TWO** new bolts, one at the seat belt retractor and the second at the seat belt anchor bracket. Refer to the note above for installation details. Tighten the new service bolts to 45 N.m (33 lb. ft).
4. Reinstall the quarter lower rear trim panel. Refer to *Quarter Lower Rear Trim Panel Replacement* in SI.
