Re: Part 573, Defect Information Report
Accessory Tonneau Cover for 2017-2020 Model Year Honda Ridgeline

Defect Information Report

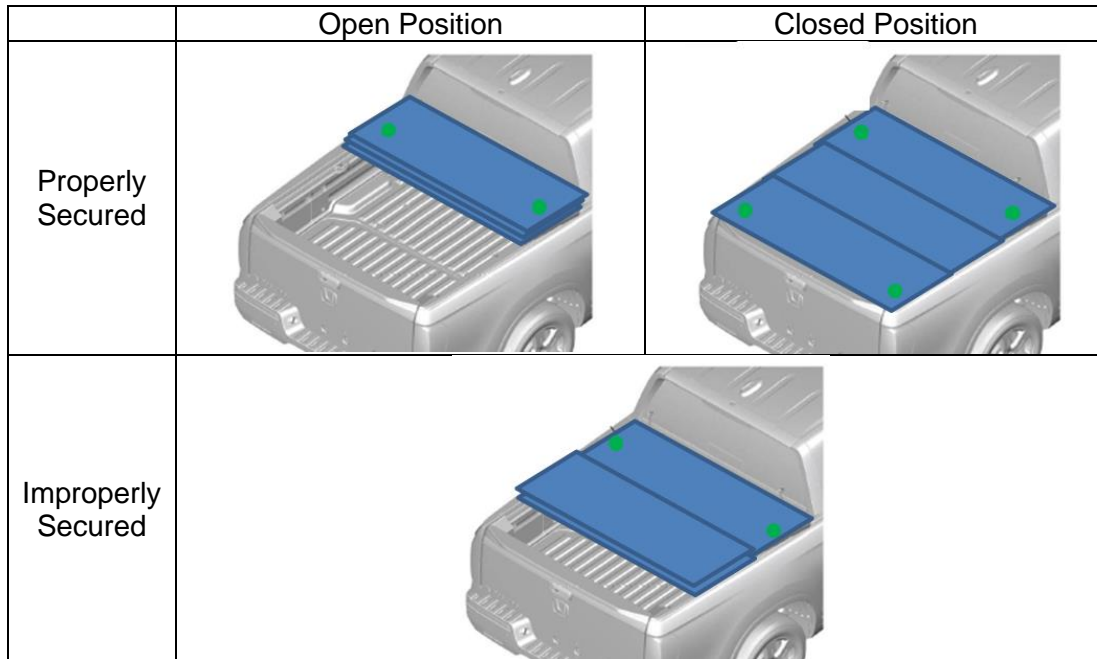
The Honda Genuine Accessory tonneau cover for 2017–2020 MY Honda Ridgeline is a tri-fold design that can be positioned to either partially cover (open) or completely cover (closed) the truck bed. If the tonneau cover is not properly secured in the open or closed position, and the vehicle is operated at highway speeds, the wind resistance may cause the tonneau cover to flip and buckle, deforming the hinges between the center and rear panel. Deformed hinges could allow the rear panel to separate from the tonneau cover, creating a road hazard and increasing the risk of a crash or injury.

Registered owners of all 2017–2020 MY Honda Ridgelines will be contacted by mail and asked to take their vehicle to an authorized Honda dealer. The dealer will inspect the vehicle for the Honda Genuine Accessory tonneau cover and if equipped, will install a tether between the tonneau cover's center and rear panel to prevent panel separation, and apply warning labels to the tonneau cover. In addition, the dealer will provide an updated accessory user's information manual which instructs the owner to properly secure the tonneau cover prior to vehicle operation.
