**Procedure Updated - May 14, 2020**

**CONDITION OF CONCERN**

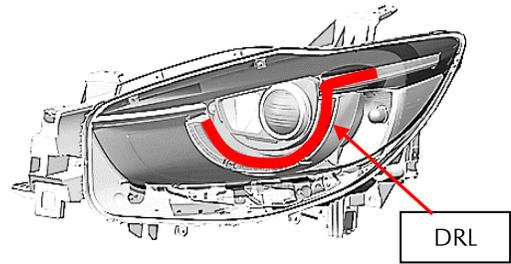
The LED type daytime running lights (DRL) may flicker or fail to illuminate while driving. If one or both DRLs fail to illuminate, the vehicle's visibility may be reduced to other drivers on the road, increasing the risk of a crash.

Due to an inappropriate material specification of the sealing gasket attached to the LED daytime running light (DRL) wiring connector, the gasket can release sulfur which may corrode the LED circuit controlling the DRL. If corrosion of the circuit develops, the circuit may lose continuity, causing flickering and/or failure of DRL illumination. One or both front DRLs on affected vehicles could be affected by this defect.

Inspect headlamp production date. Lamps that fall within the production date then require an inspection of the DRL operation. If a flickering or failure to illuminate condition is observed on the DRL, replace the failed headlight unit(s) with good one(s). On the affected headlight unit(s), install desulfurizing materials (gas absorption sheets) and replace sealing gaskets with improved ones.
