ALA5 Stop Sale – Preliminary check instructions

Cayenne (9YA), Cayenne Coupé (9YB) – MY 2020

Checking an ATF oil line at the Tiptronic transmission

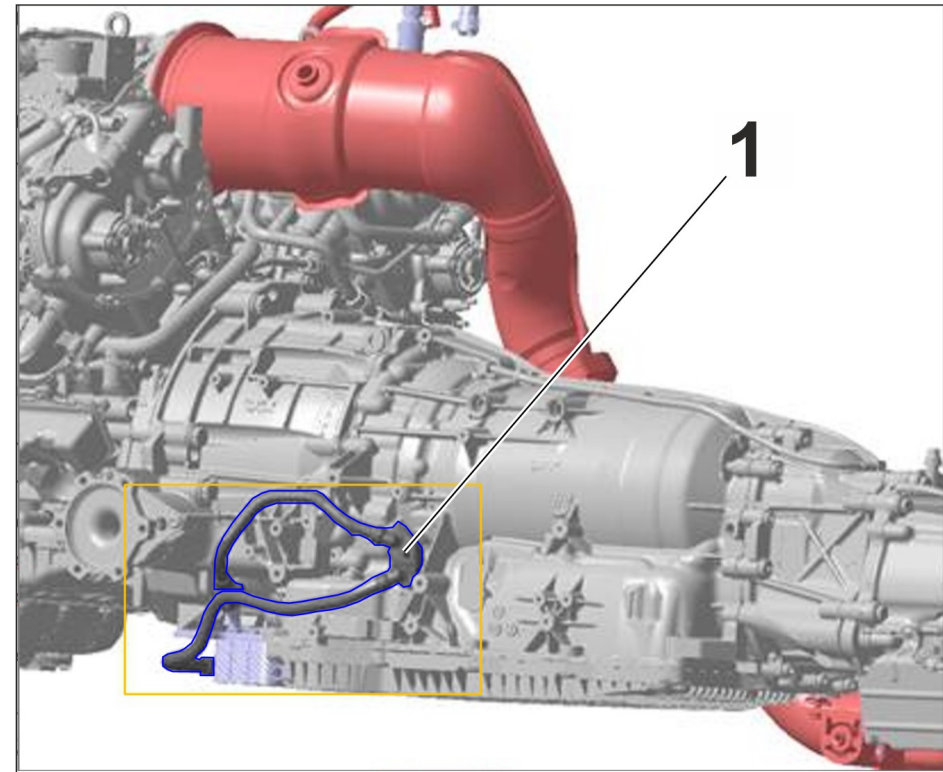
The vehicle may leak transmission fluid due to a possibly insufficient weld on a transmission oil pipe.

(1) ATF oil line (**checking**)

Checking the production date of the ATF oil line.

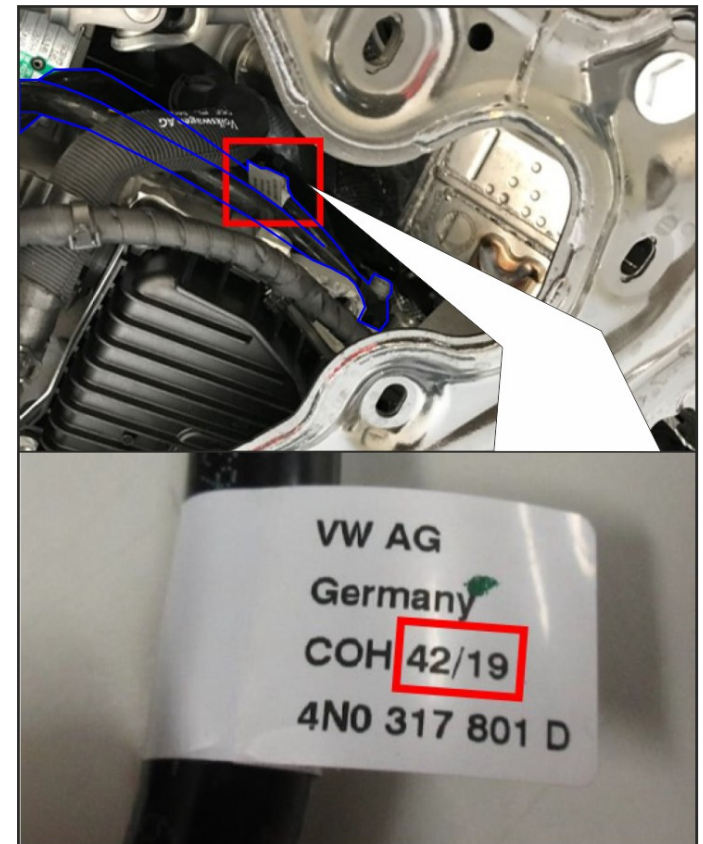
To do this, read out the **production calendar week** of the oil line from the **label attached to the line**.

- The production calendar week is **outside of the period** calendar week **36/2019 through 42/2019, inclusive**.
⇒ **The installed ATF oil line is not affected, proceed with chapter “Subsequent work“.**
- The production date of the oil line is **within calendar week 36/2019 through 42/2019, inclusive**.
⇒ **The welding of the ATF oil line is not correct.**
⇒ **The affected vehicle remains blocked until the publication of the remedial measure and must not be delivered to the customer.**
⇒ Complete the vehicle provisionally and remove it from the lifting platform.
