RE: **Recall Campaign Launch Notification**

**Check Front Seat Belts
MY17-21 A205 (C-Class Cabriolet)**

Campaign No. 2021020010, February 2021

SUBJECT: **Model C-Class Cabriolet vehicles (A205 platform)**
Model Year 2017-2021
Check Front Seat Belts (Driver and Passenger)

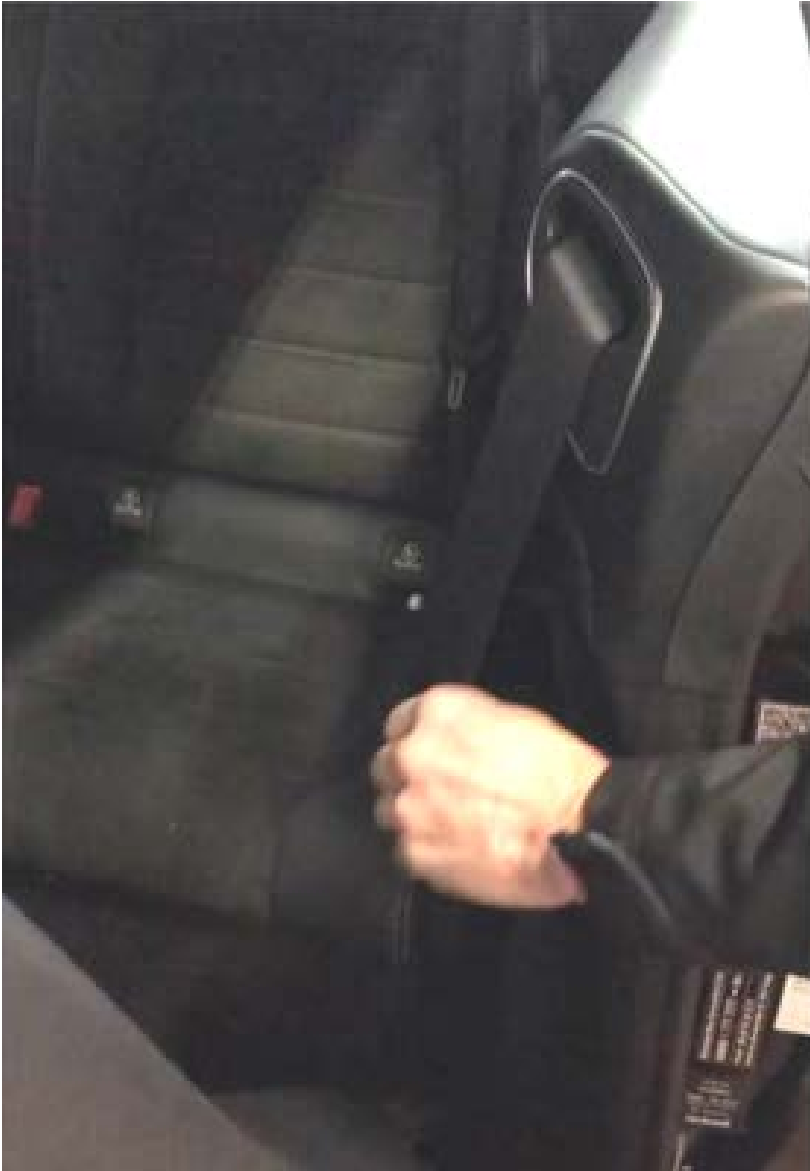
**Figure 1**

1. Pull out seat belt straps of driver's and front passenger's seat belts and let them retract (**Figure 1**).
i The seat belt strap **must** retract into its final position automatically. Provide manual assistance with rolling up the seat belt strap if necessary.

- a. Seat belt strap does **not** roll up into its final position automatically despite manual assistance: Carry out **work procedure**.
- b. Seat belt strap rolls up into its final position automatically: **End measure**.
